Floods and Debris Flows in the Catalina Front Range

July 31, 2006

Bob Webb, Peter Griffiths, Chris Magirl, and Diane Boyer, USGS
Erik Pytlak, Craig Shoemaker, and Michael Schaffner, NWS
Phil Pearthree and Ann Youberg, Arizona Geological Survey

The Extreme Precipitation Event of July 31, 2006, and Its Effects

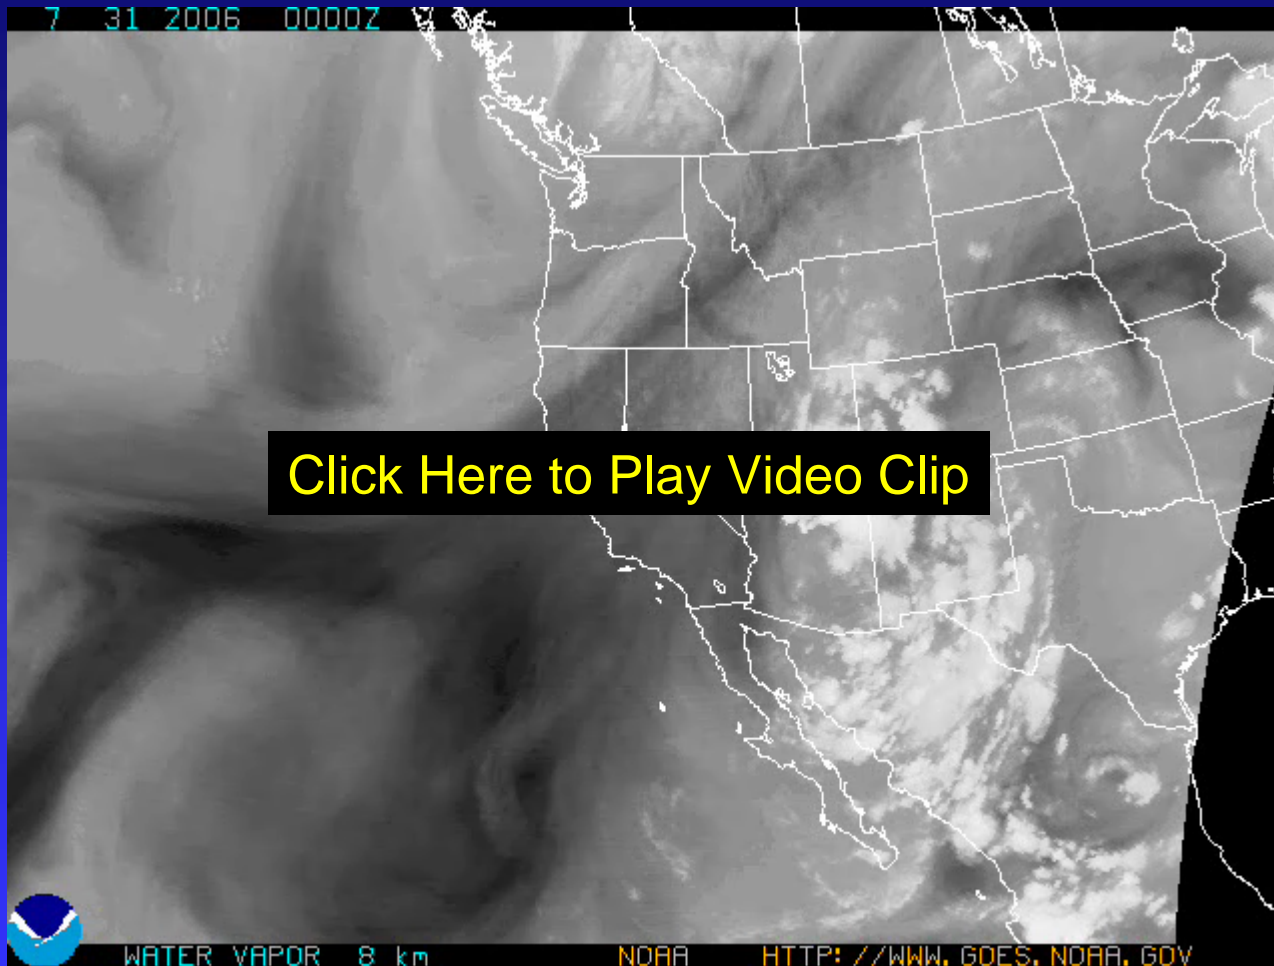
GOES Water Vapor Imagery from July 31, 2006

Upper-level low-pressure system over New Mexico steered moisture into southern Arizona over a five-day period.

Early in the morning on July 31, a series of thunderstorms moved southwards from the Phoenix area through northeastern Pima County.

Half-hour images; white indicates high atmospheric water content

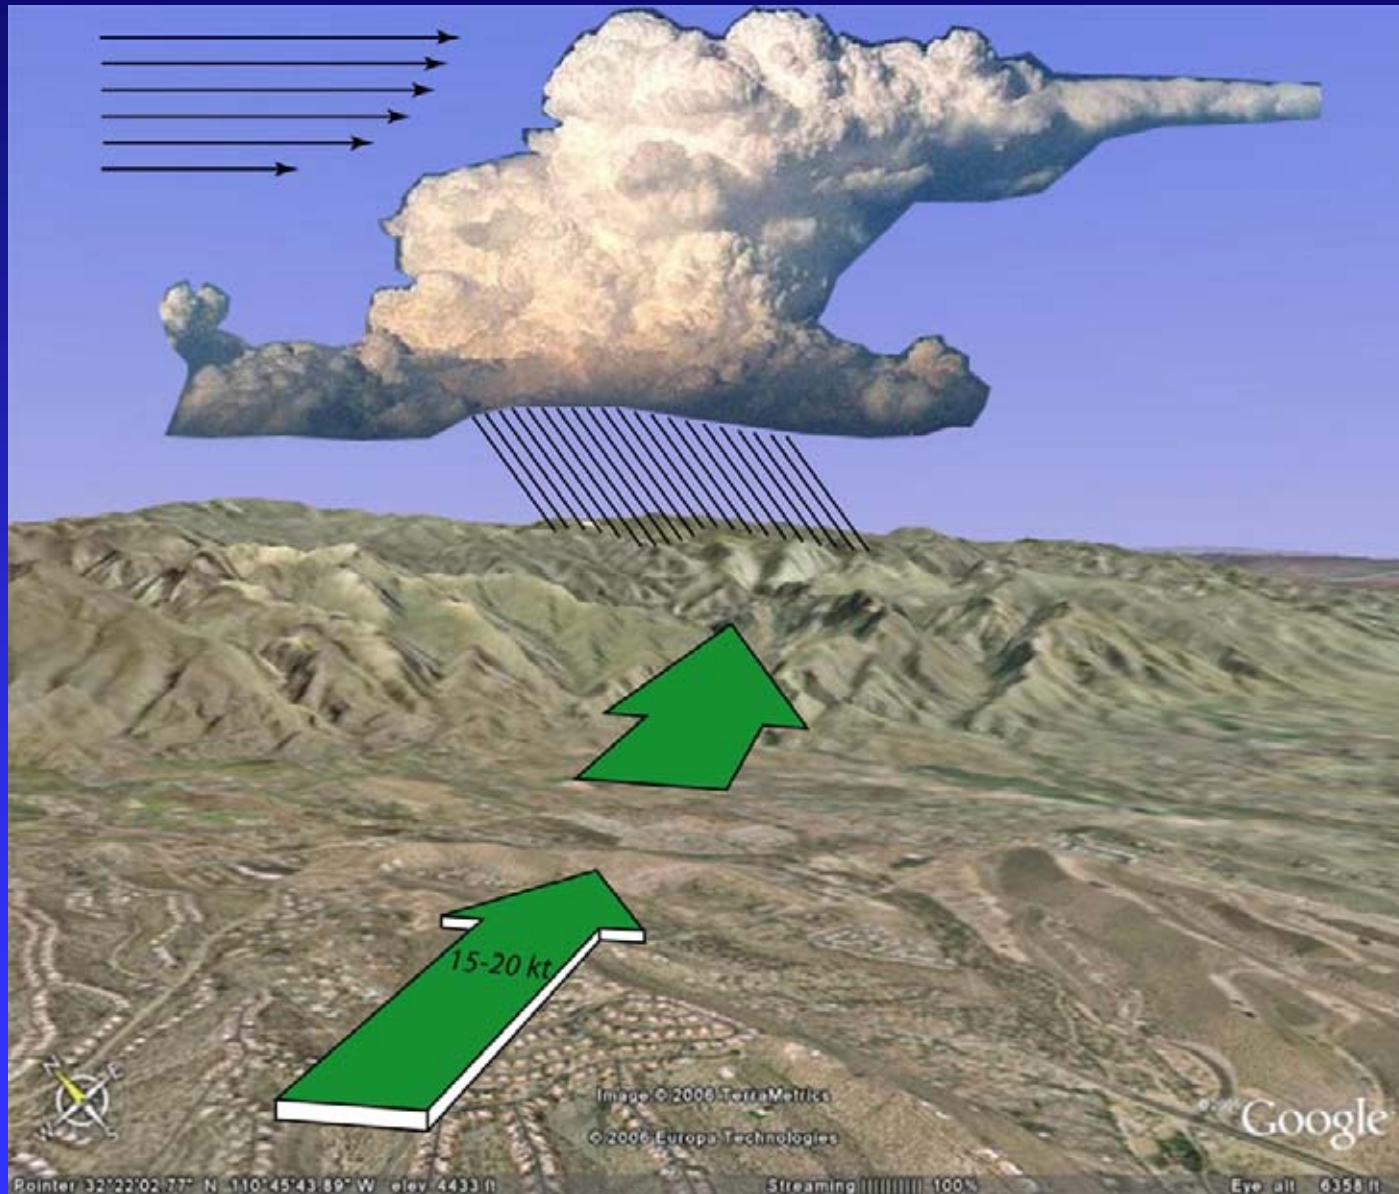
Upper-Level Shear From Northwest; Lower-Level Jet from Southwest

Wind and water vapor movement was like a firehose aimed straight up over Sabino Canyon and other Santa Catalina Mountain tributaries the morning of July 31.

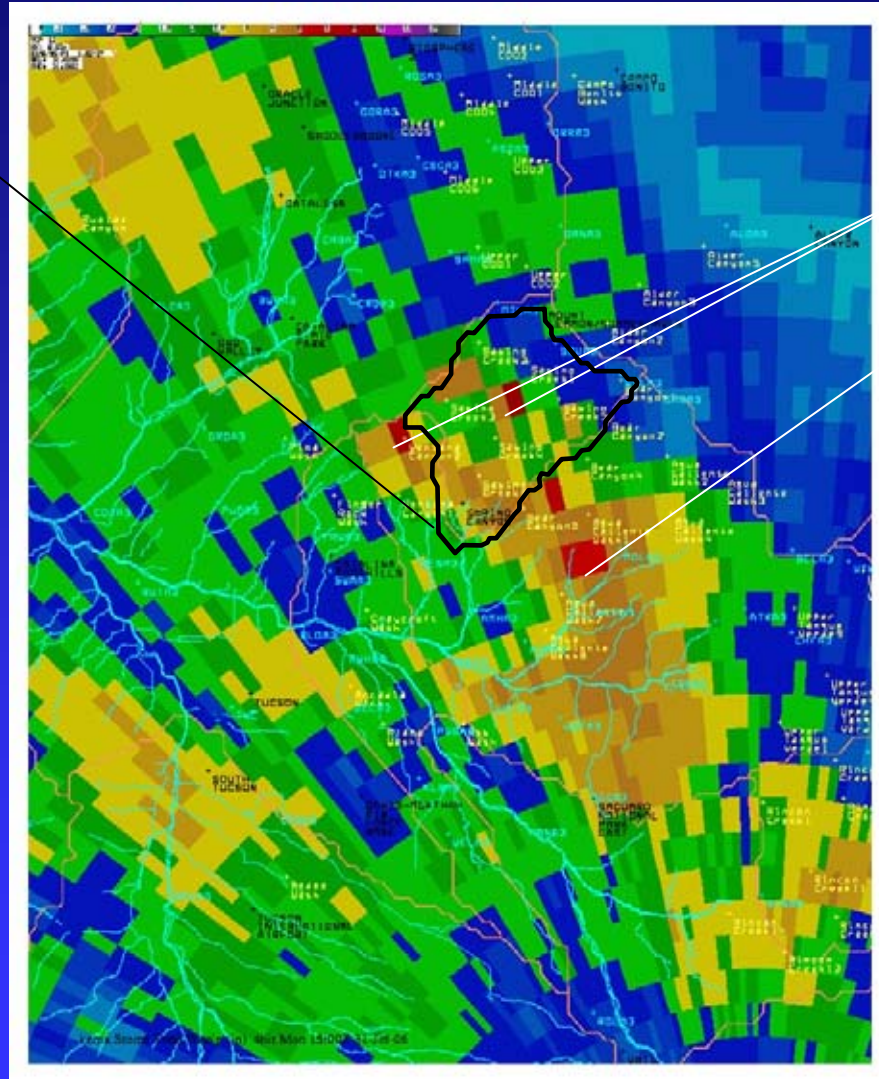
Total Storm Precipitation from NEXRAD Weather Radar

Sabino watershed

8-10"

5-6"

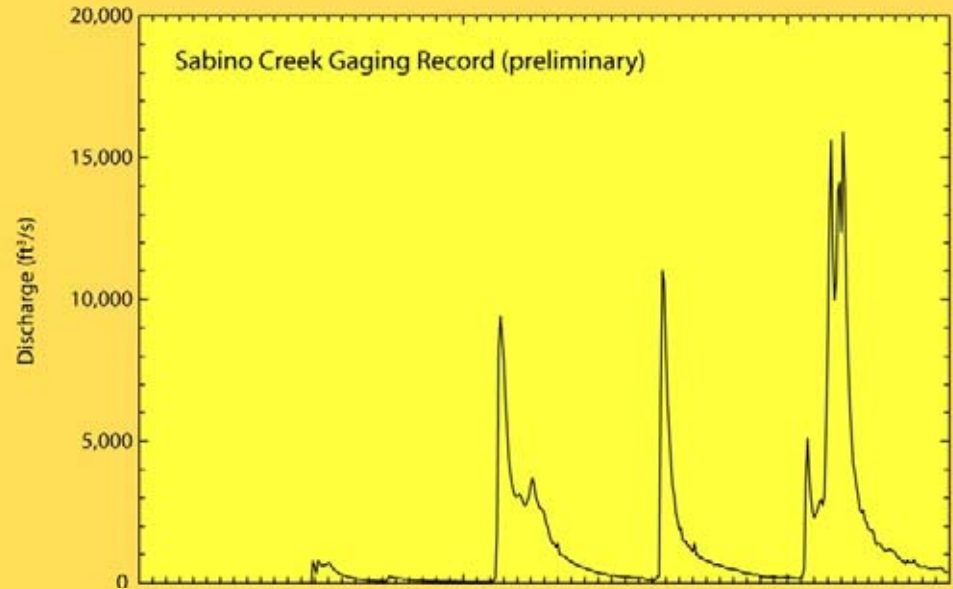
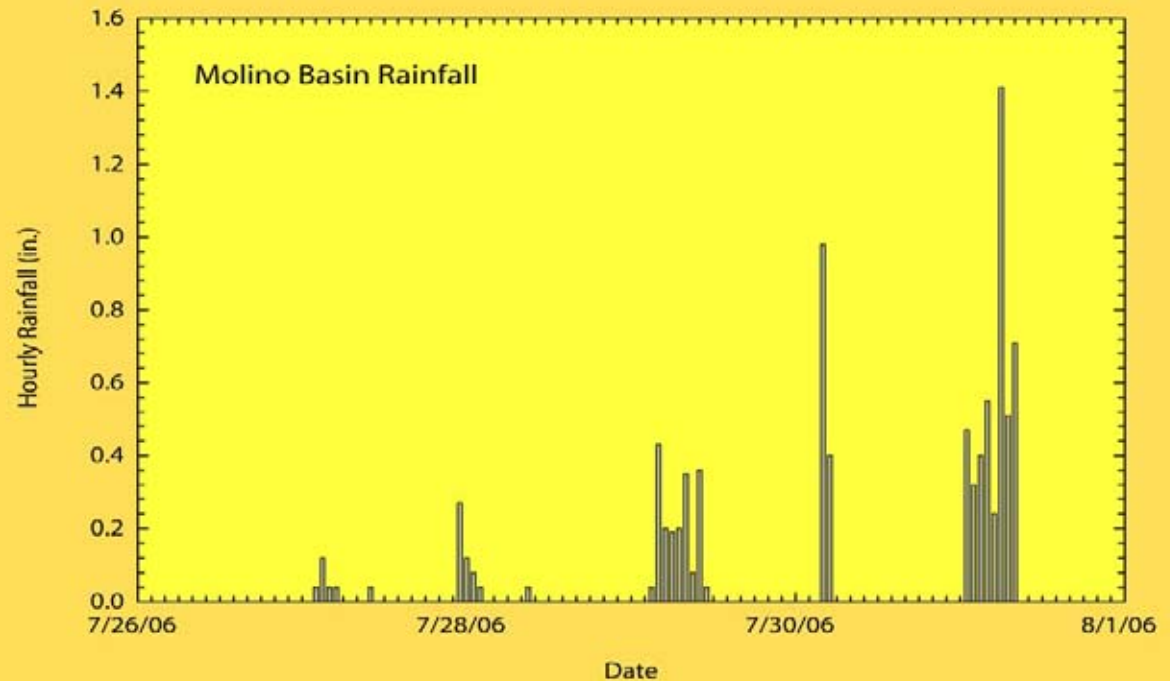
Streamflow and Precipitation

July 26-July 31

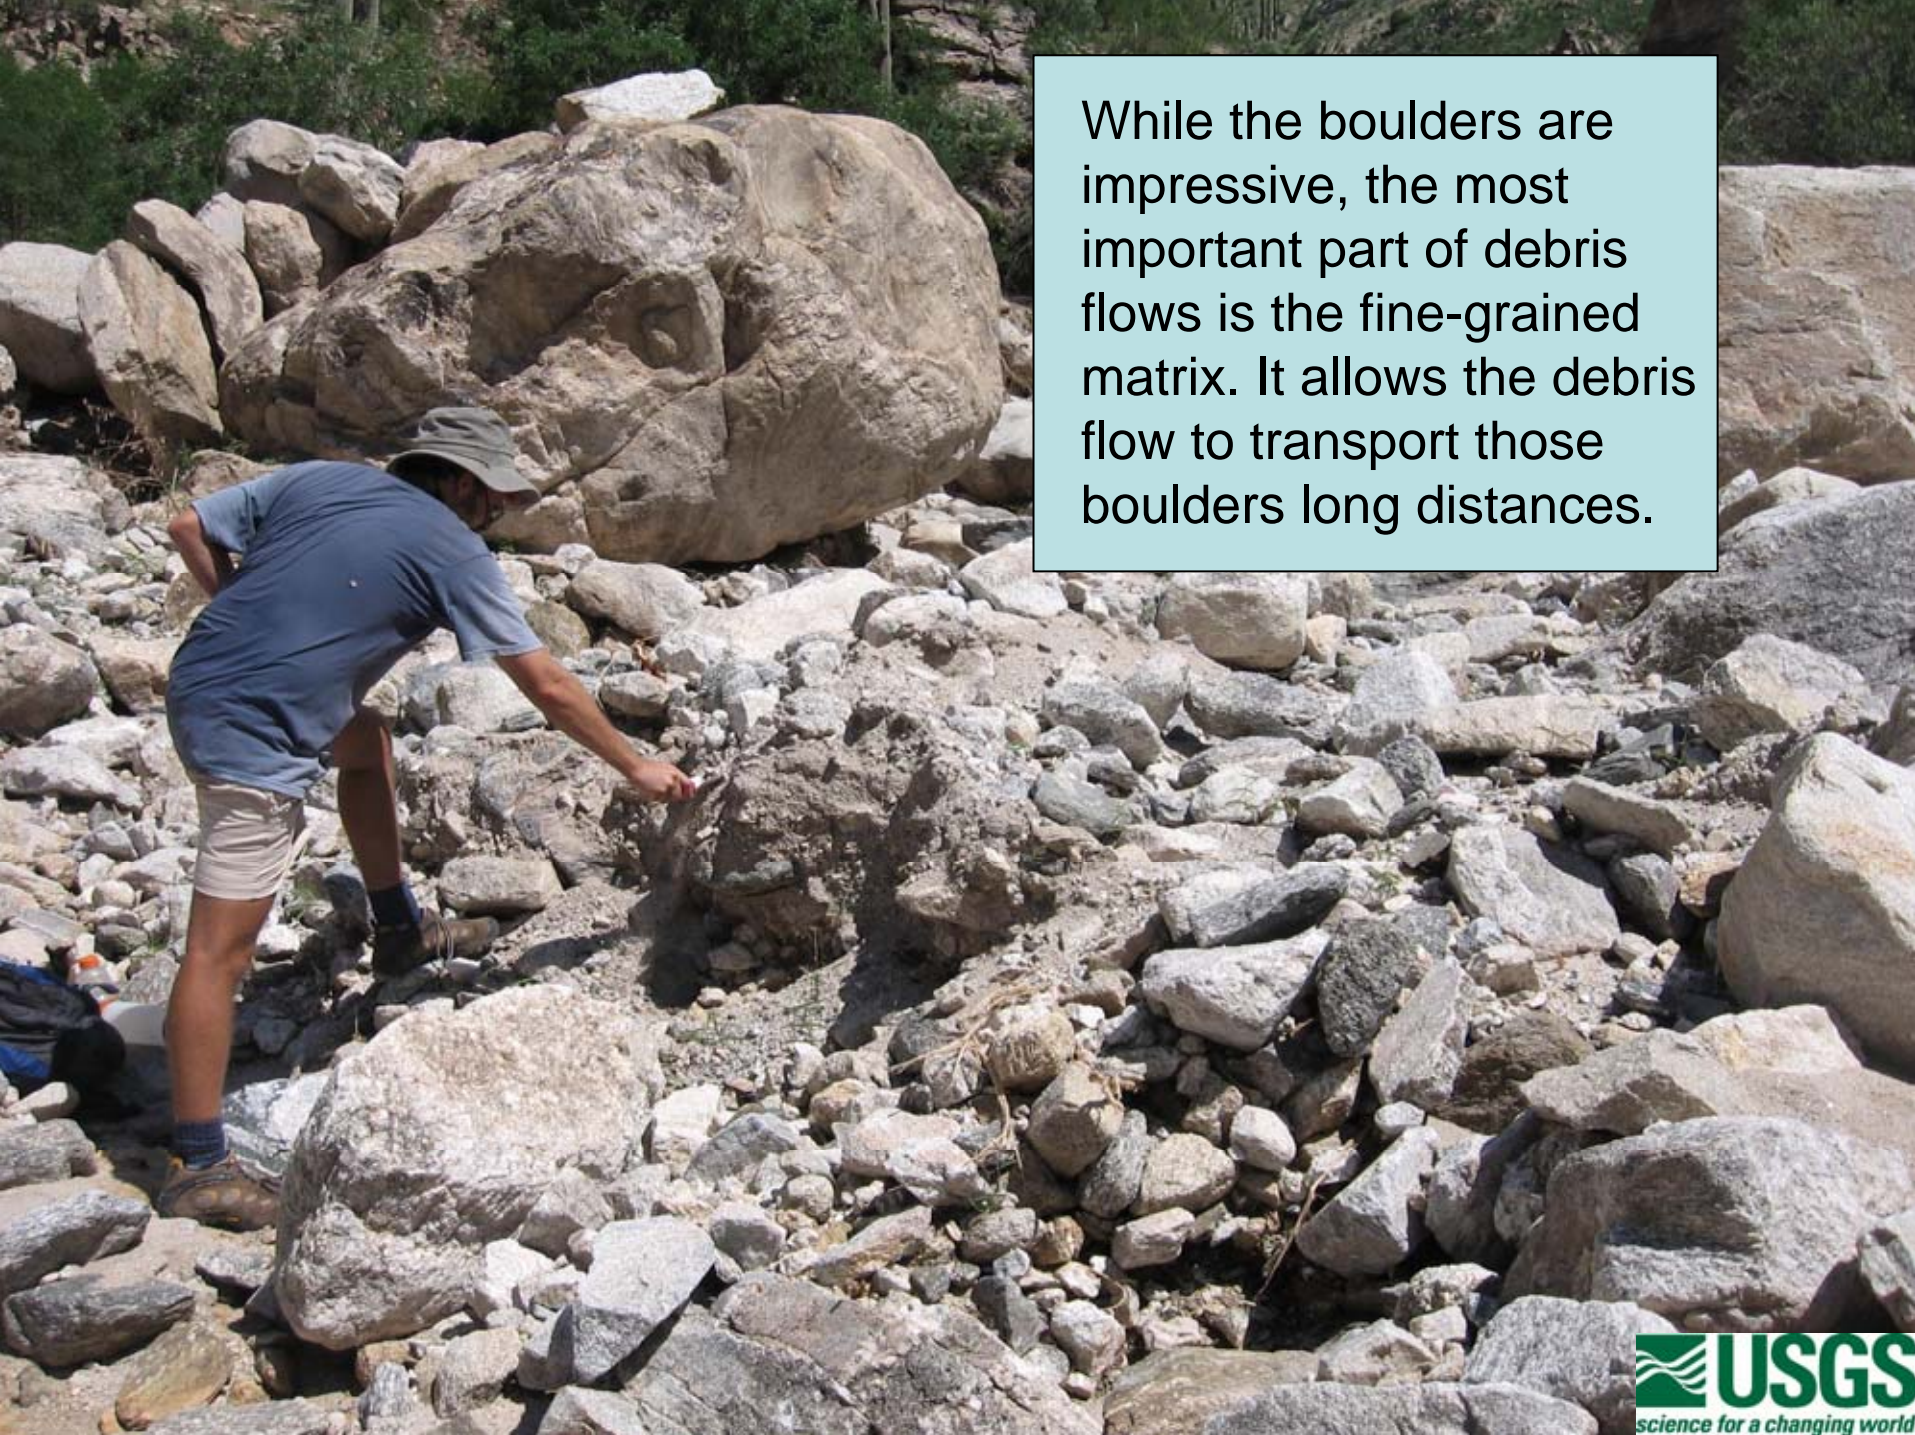
While the boulders are impressive, the most important part of debris flows is the fine-grained matrix. It allows the debris flow to transport those boulders long distances.

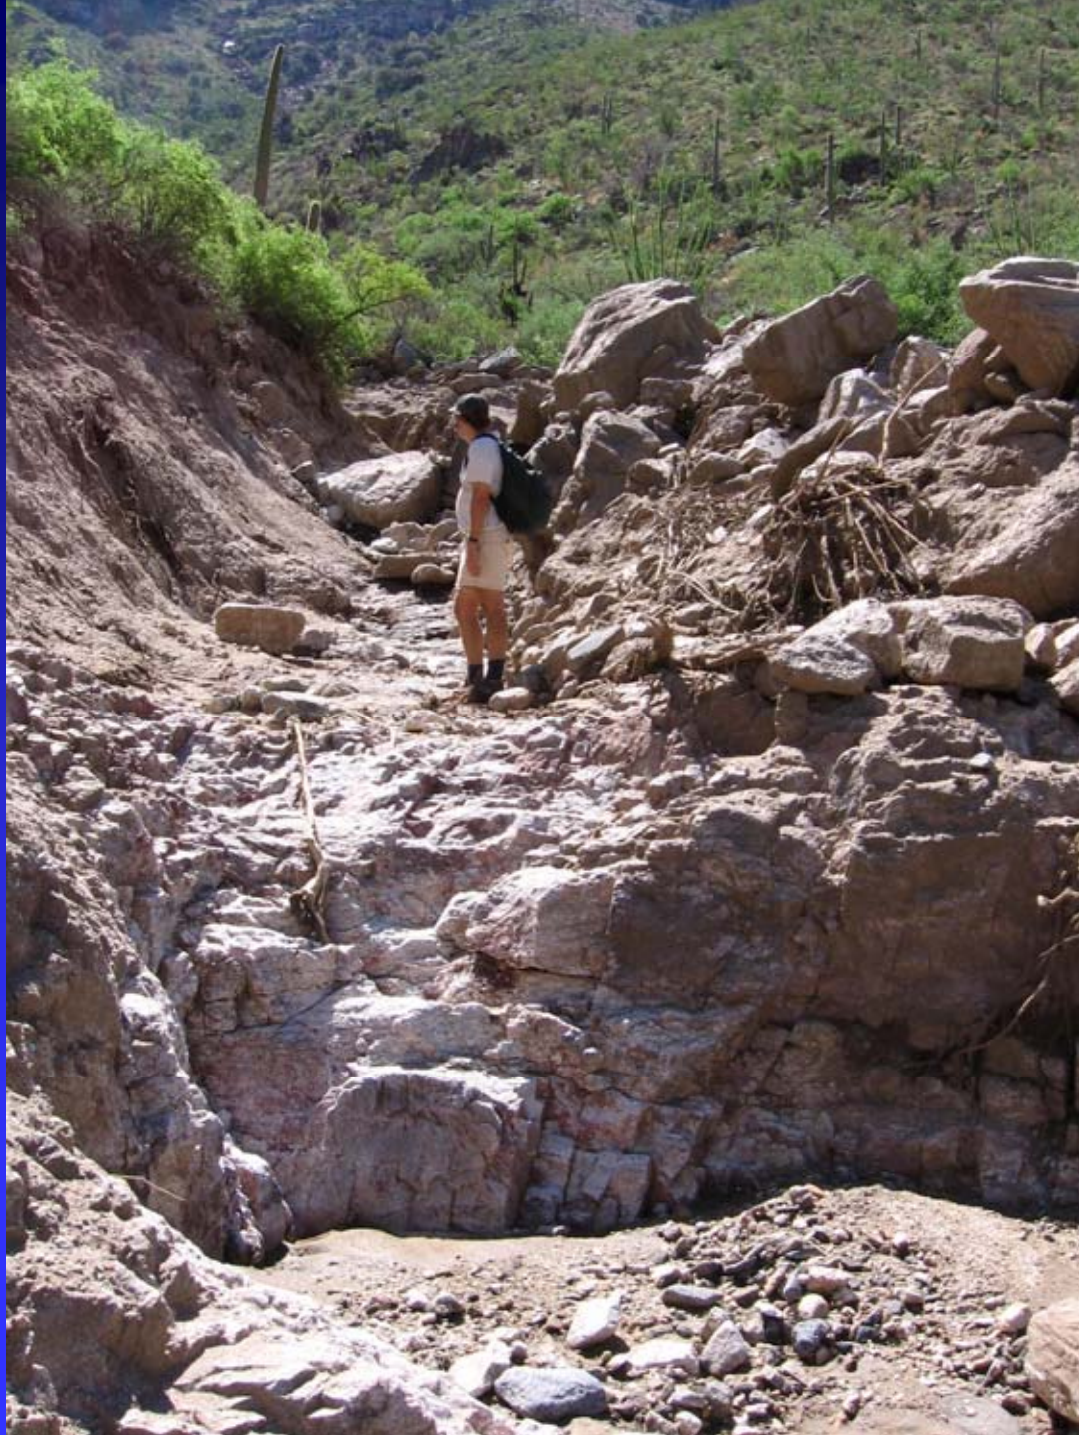
*Scour from
DF #7*

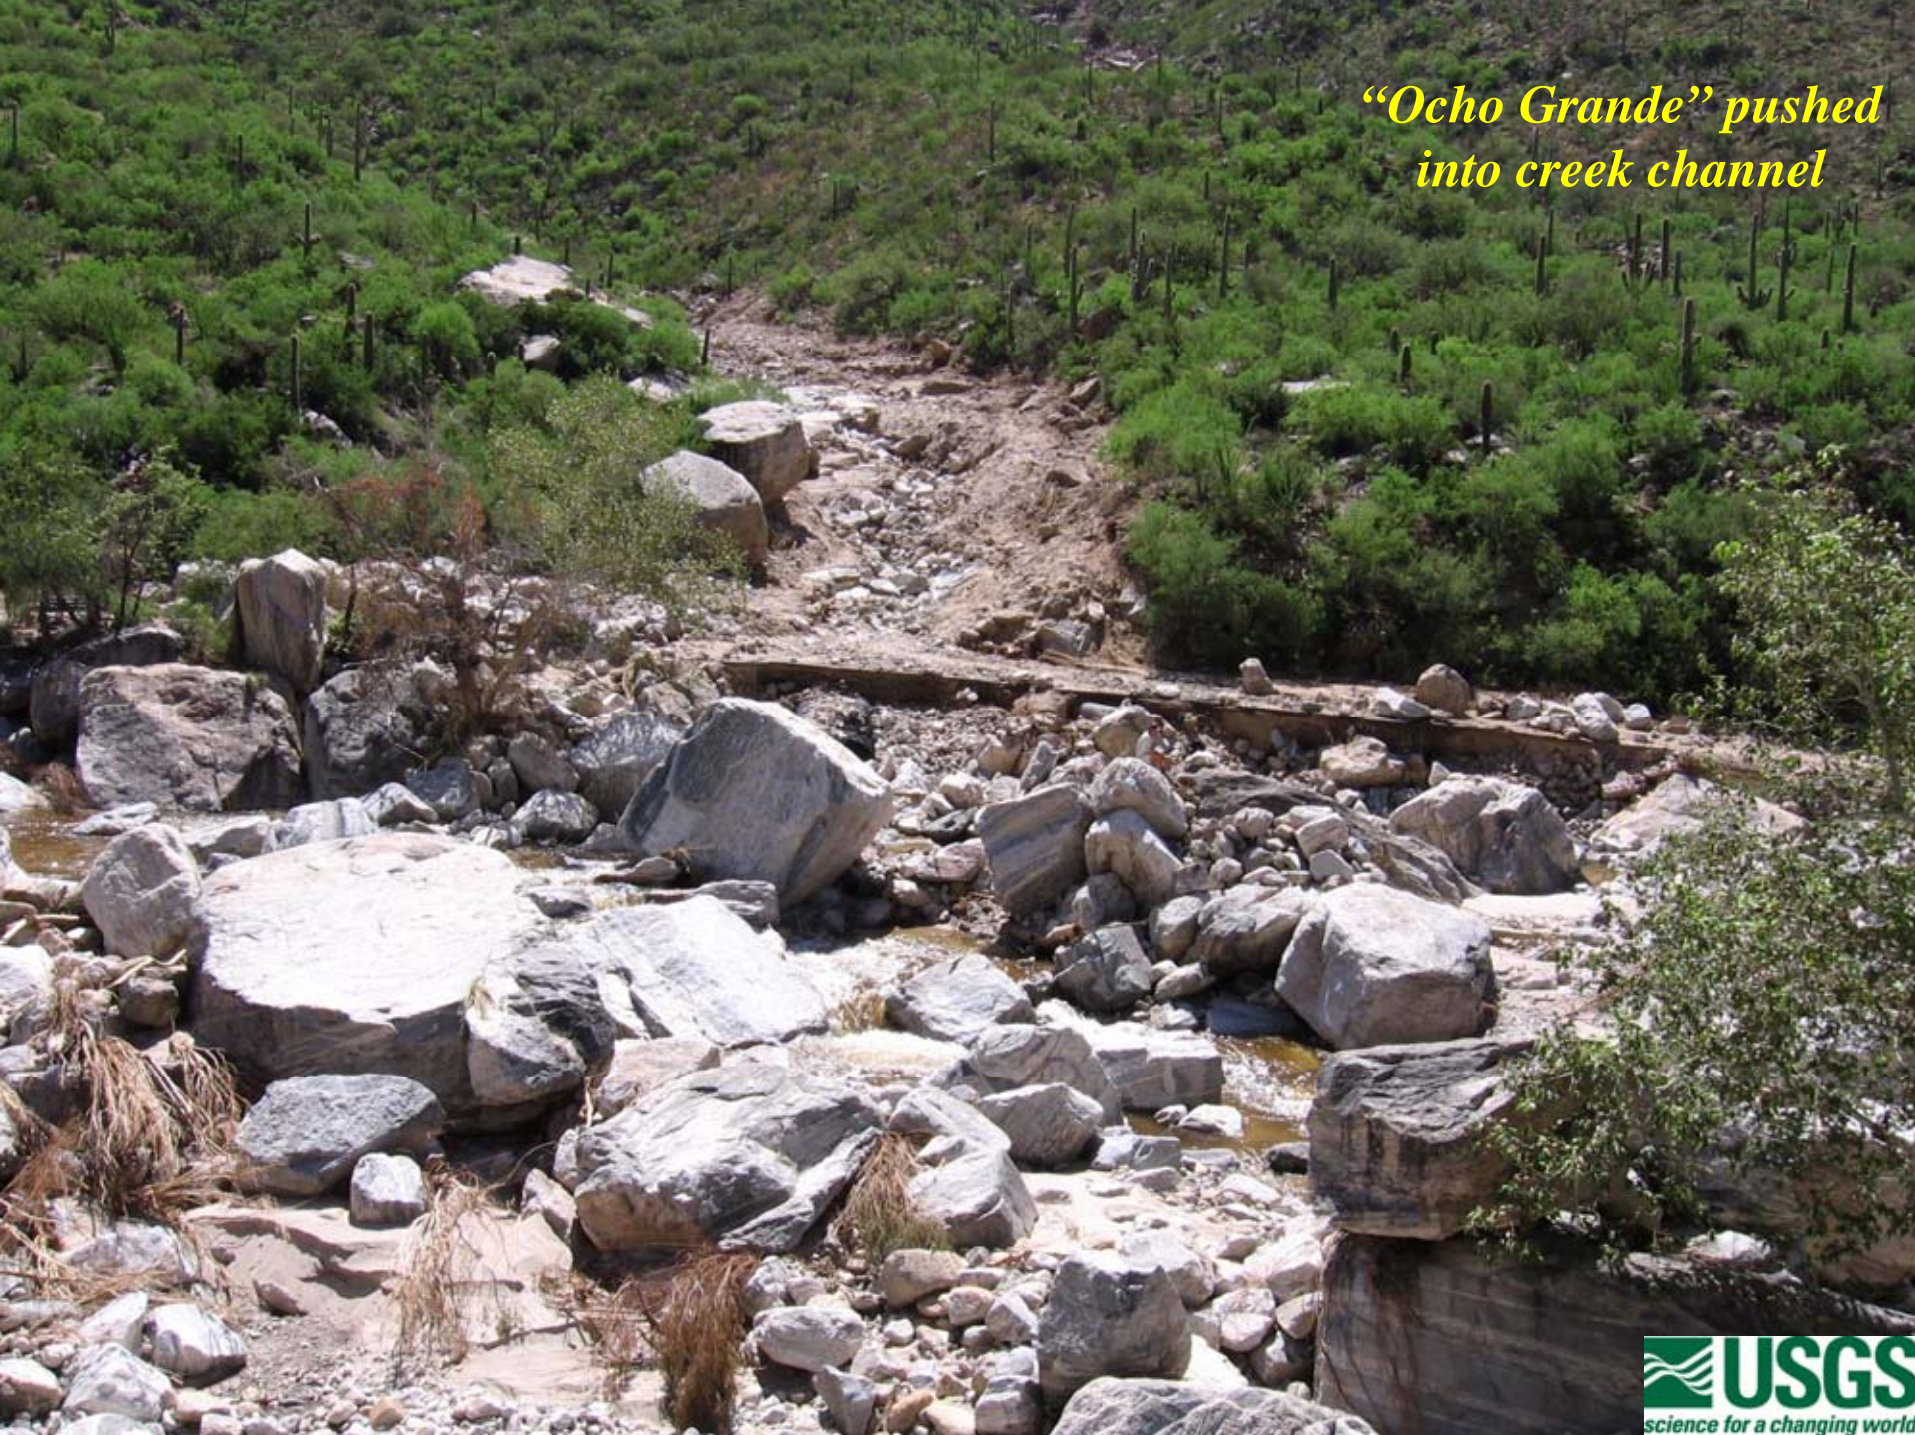
*“Ocho Grande” pushed
into creek channel*

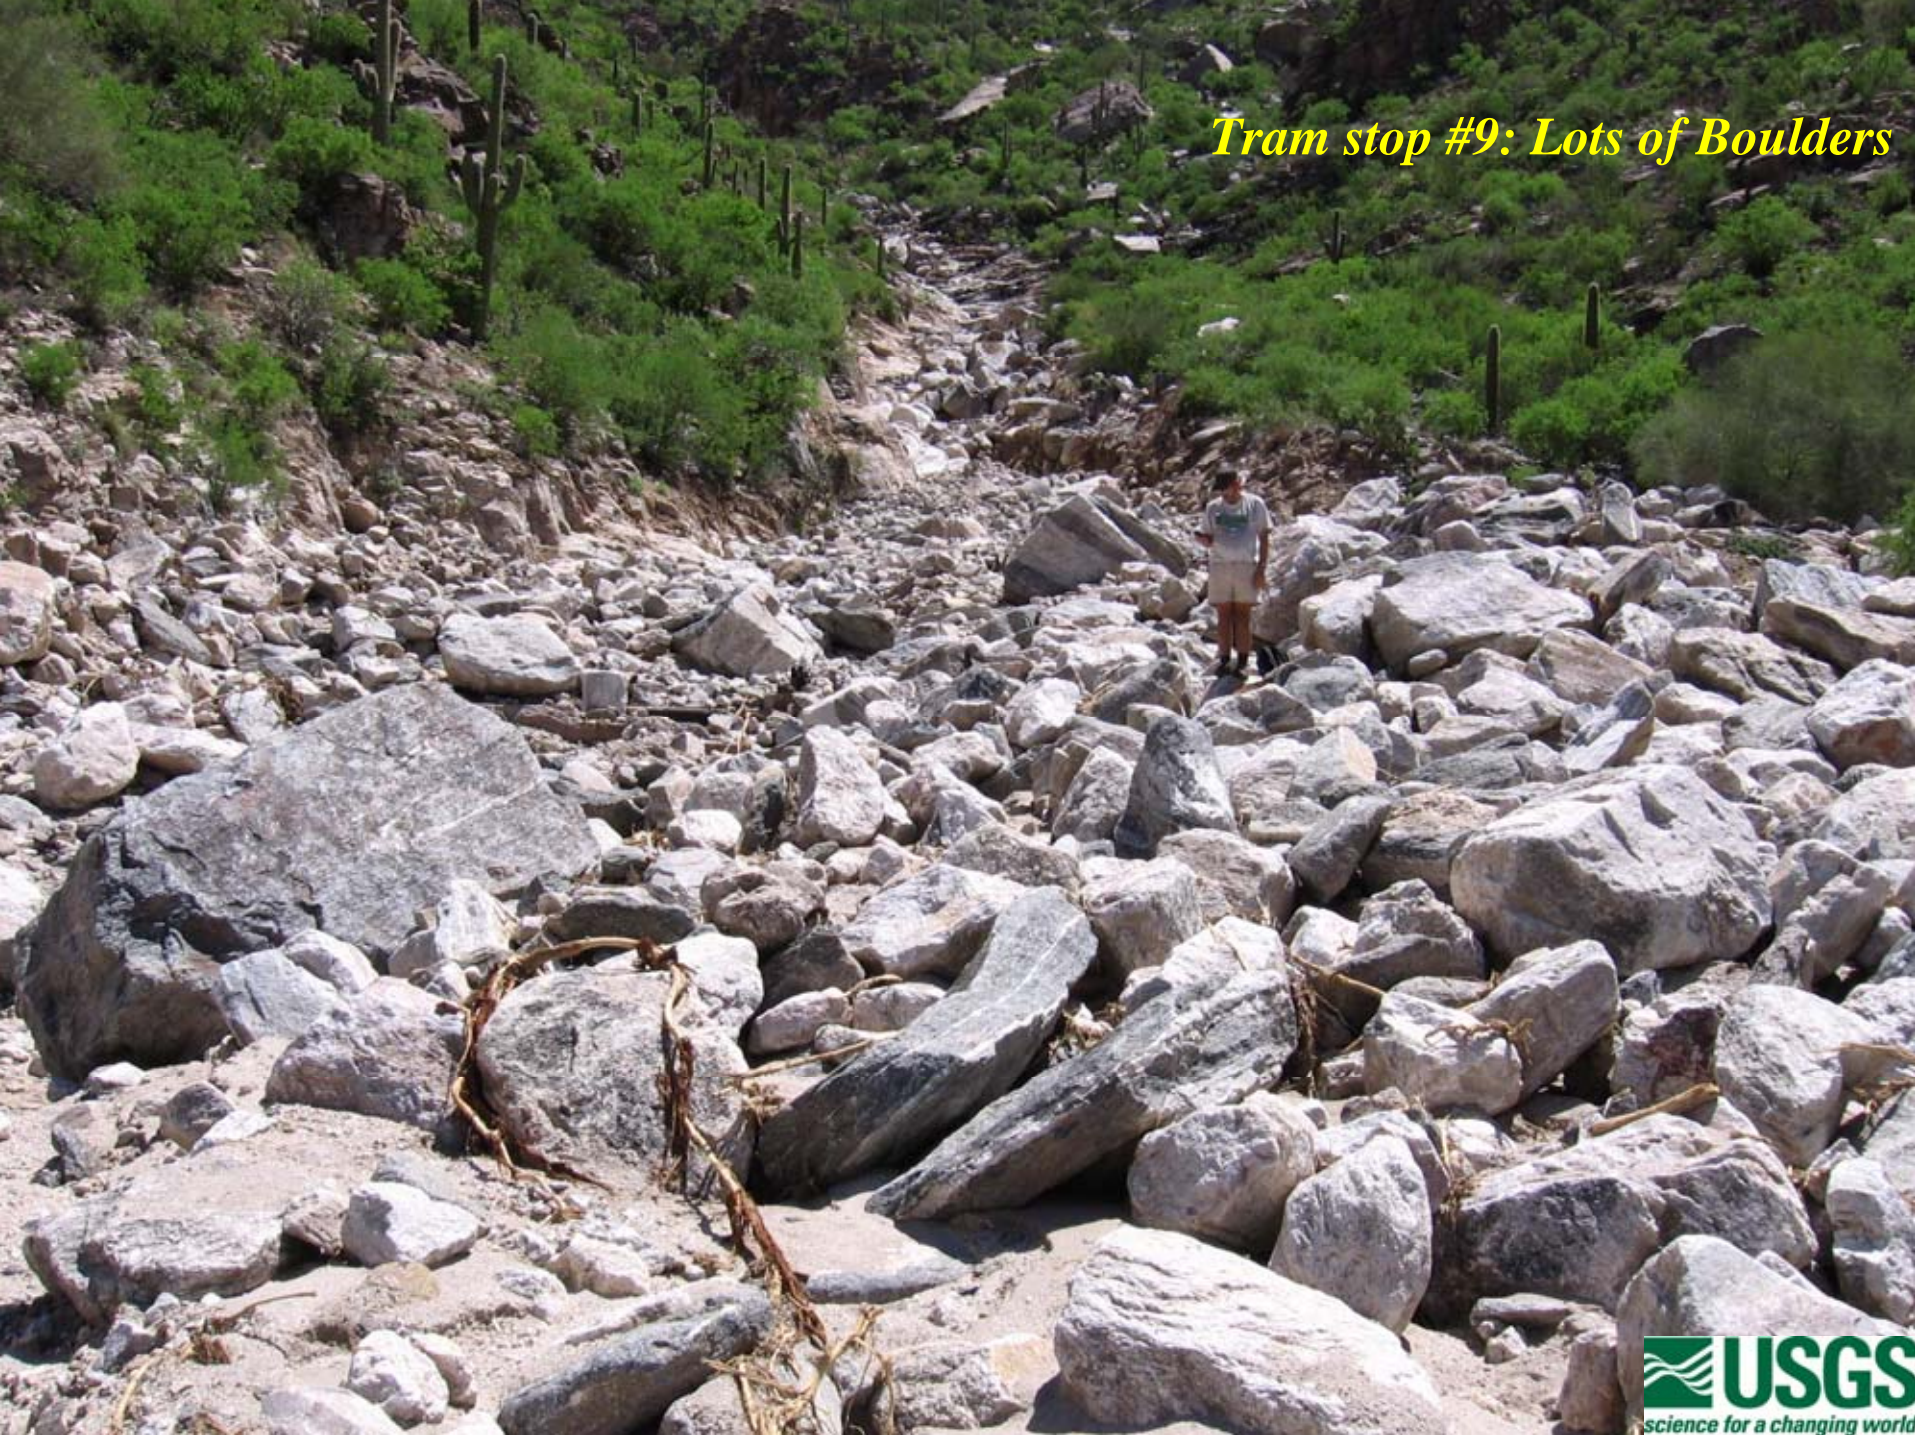
Tram stop #9: Lots of Boulders

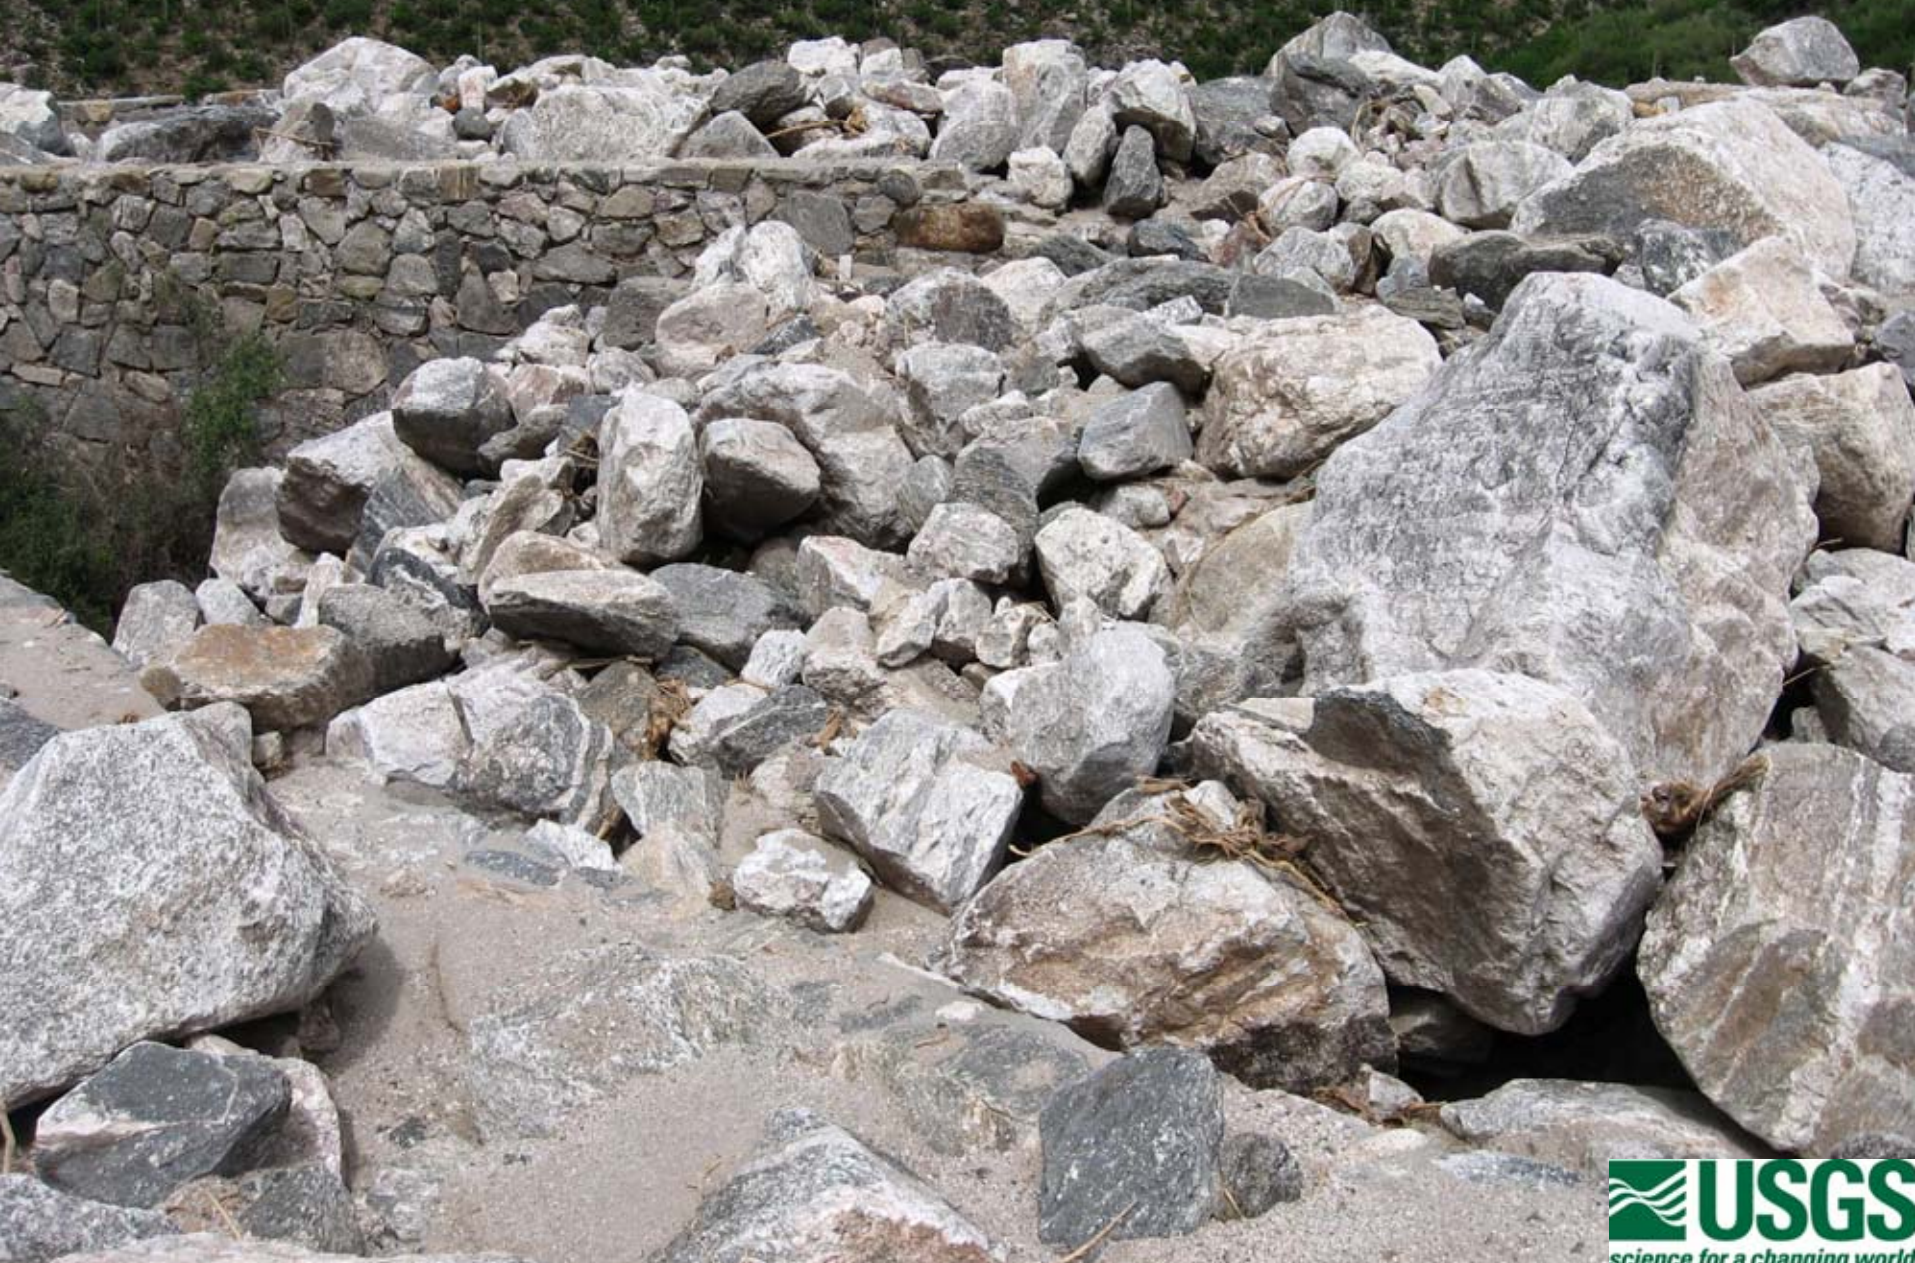
Bridge outlet is choked with boulders

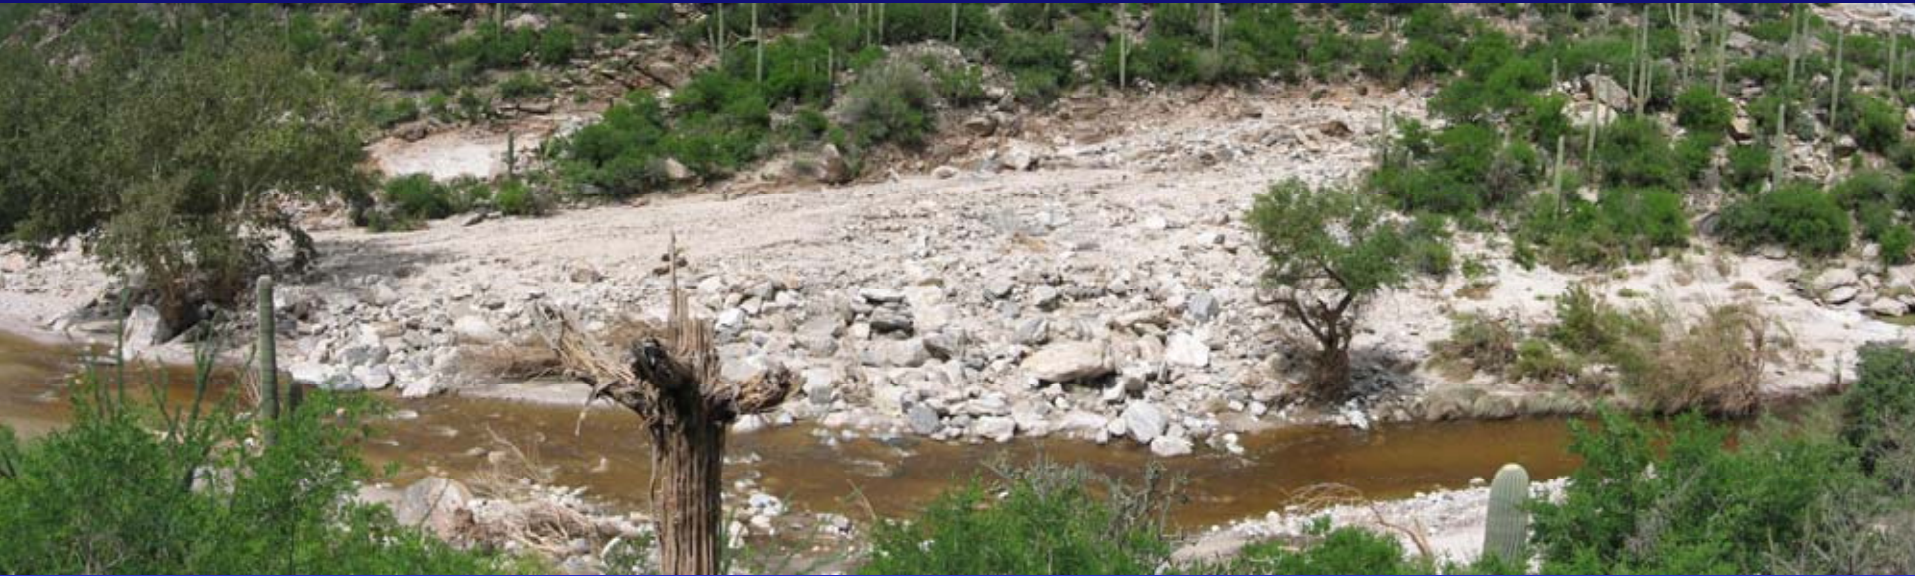
Debris Flow #10 and Sabino Creek

- A lot of sediment entered into the mainstem of Sabino Creek.
- A process known as reworking entrained the finer sediments, washing them downstream.
- The high sediment load led to deposition far downstream in Sabino Creek.

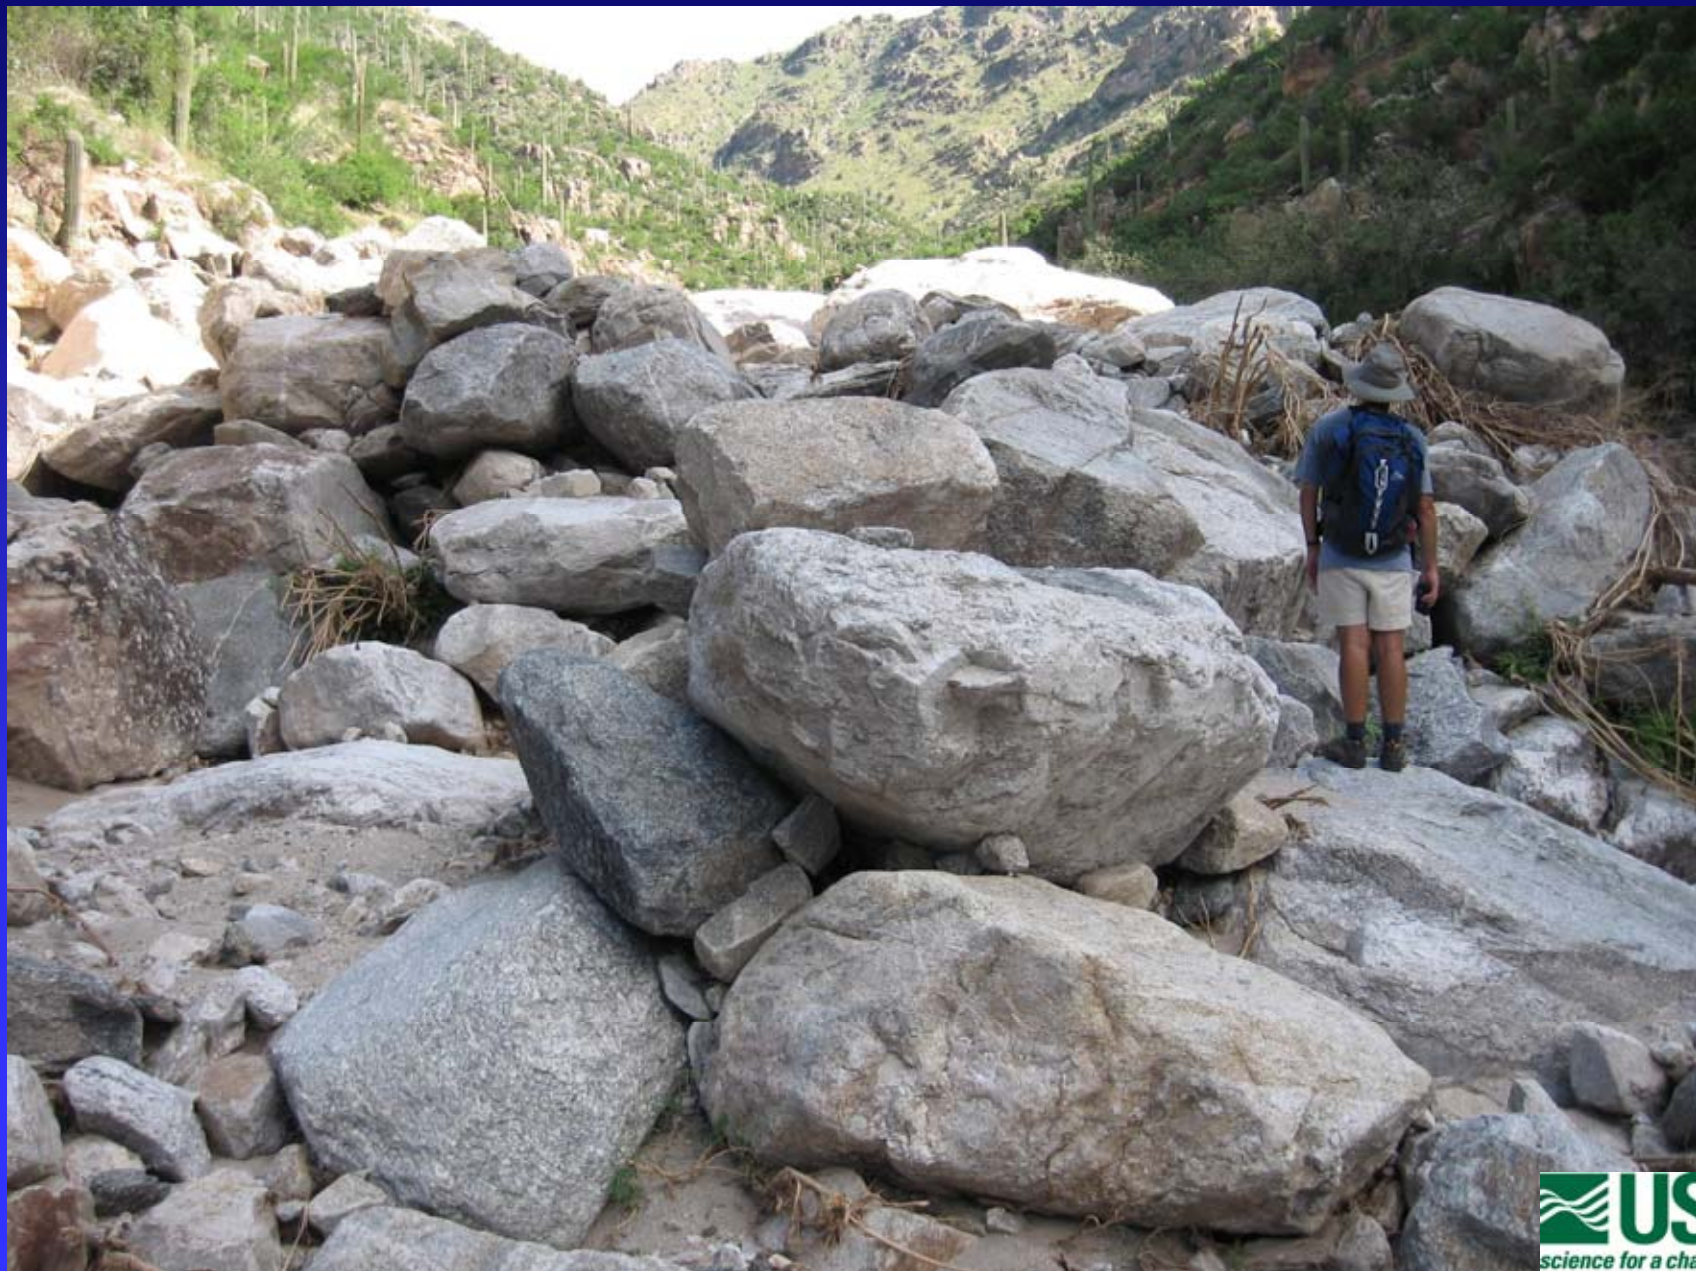
On the ground in Rattlesnake Canyon

Alternating debris-flow and hyperconcentrated-flow impulses

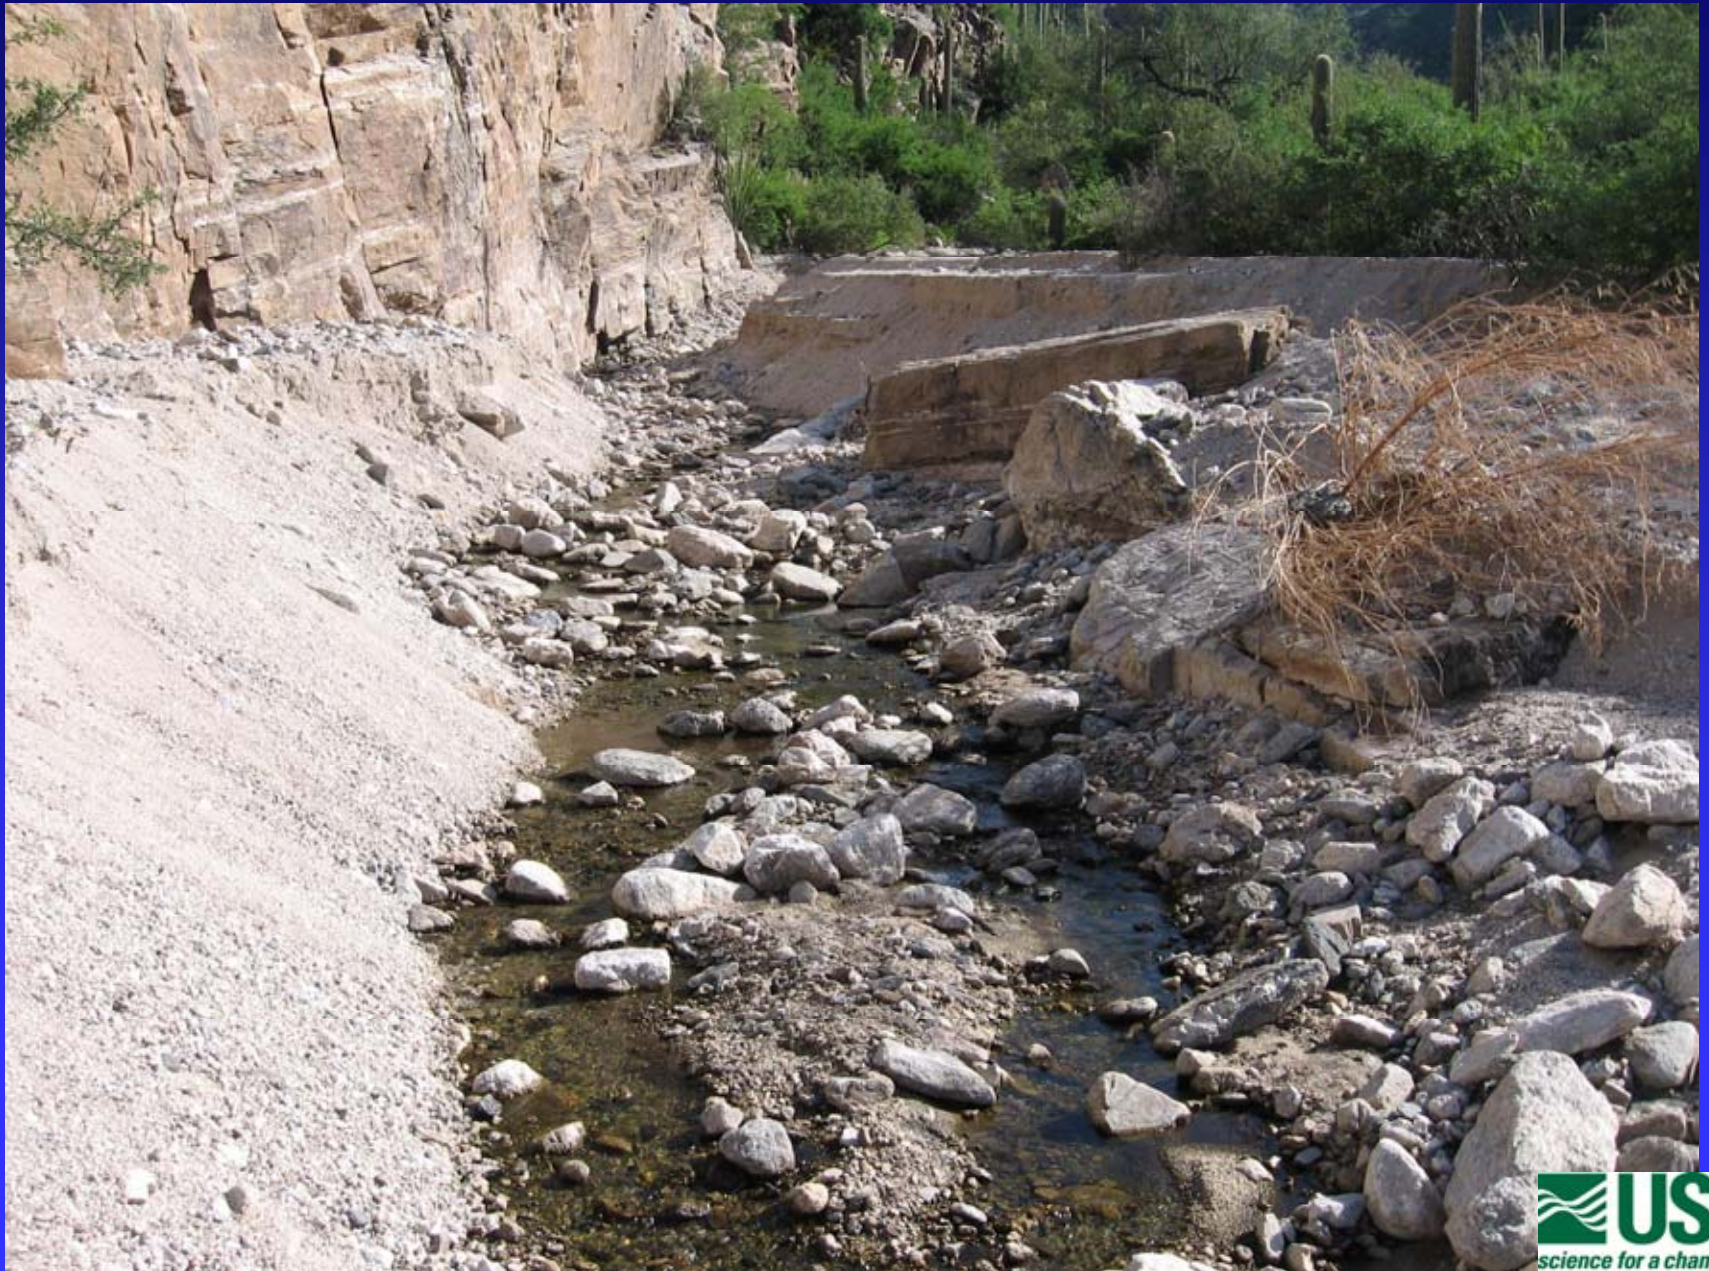
Fresh debris-flow levees were deposited onto old DF levees
