Floods and Debris Flows in the Catalina Front Range

July 31, 2006

Bob Webb, Peter Griffiths, Chris Magirl, and Diane Boyer, USGS
Erik Pytlak, Craig Shoemaker, and Michael Schaffner, NWS
Phil Pearthree and Ann Youberg, Arizona Geological Survey

The Extreme Precipitation Event of July 31, 2006, and Its Effects

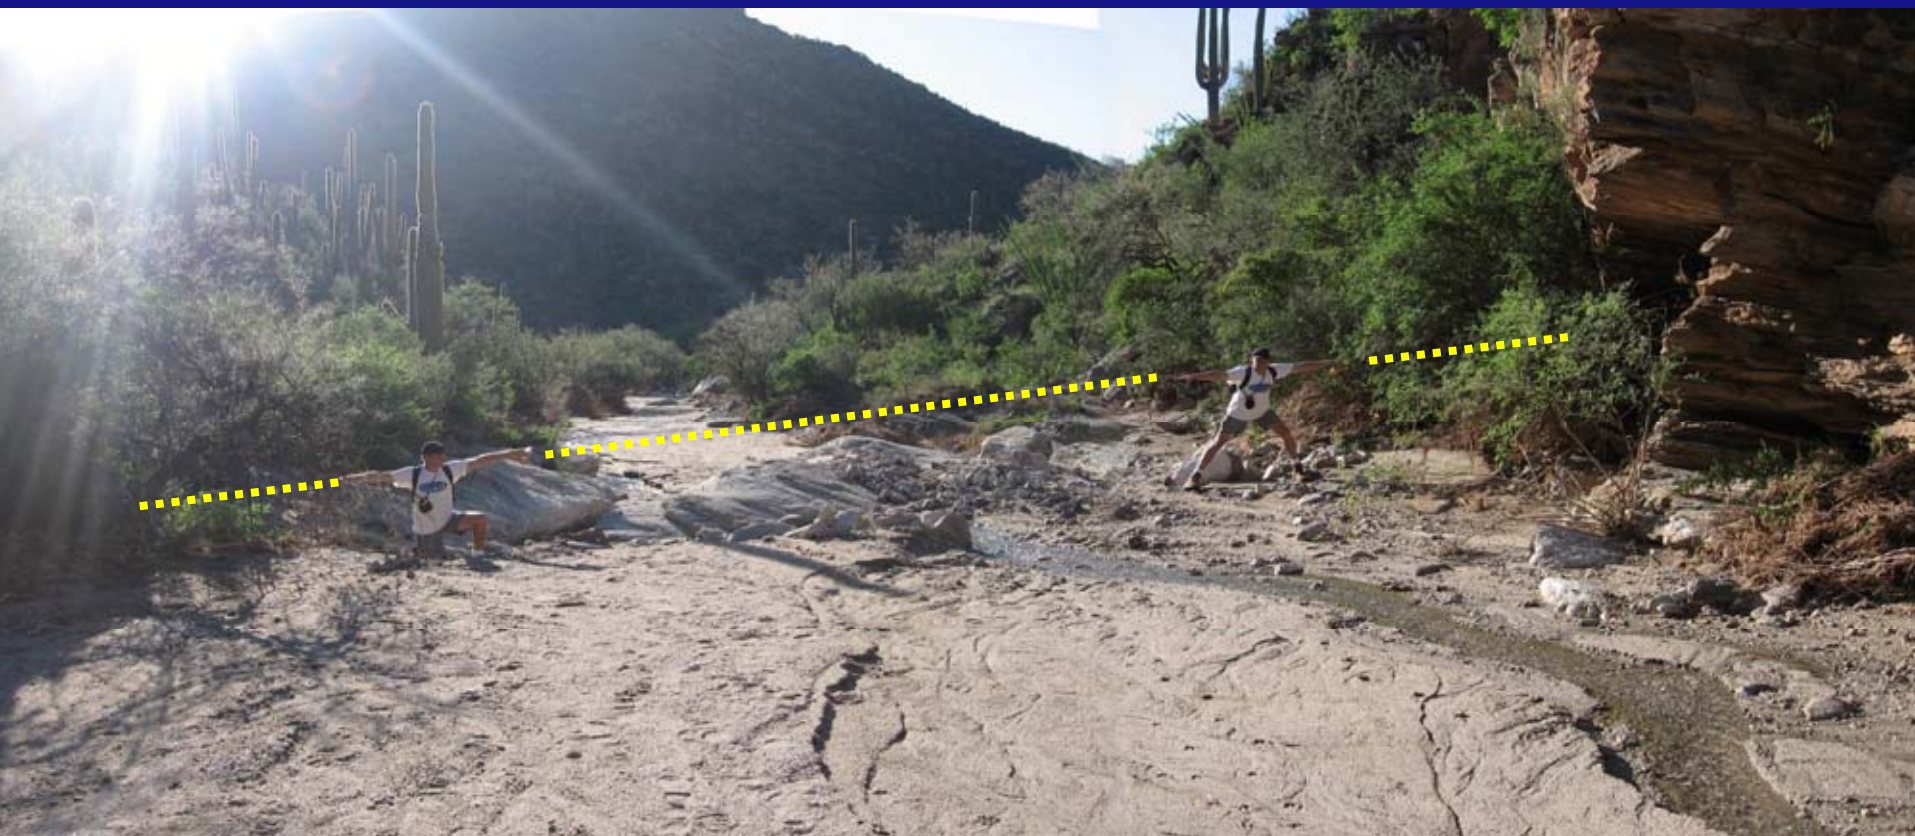
Rattlesnake Canyon

Max depth of the Rattlesnake debris flow was modest...

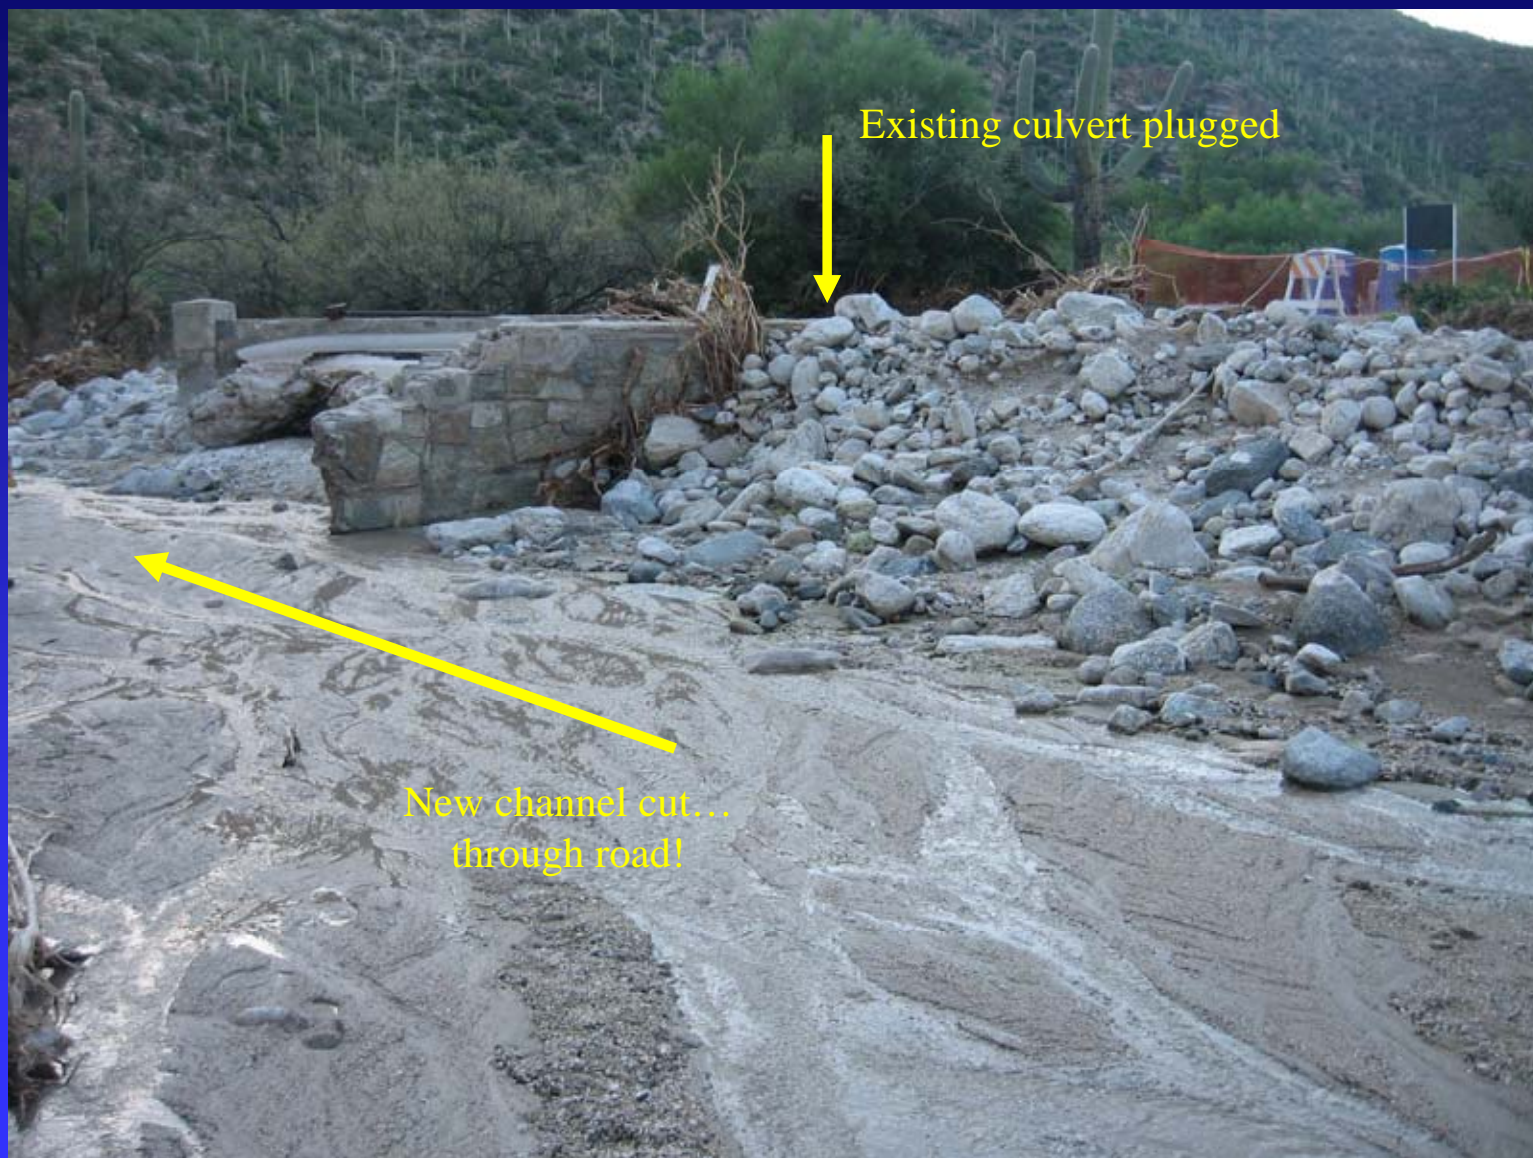
Sabino Canyon tram road at Rattlesnake

...but the damage was significant

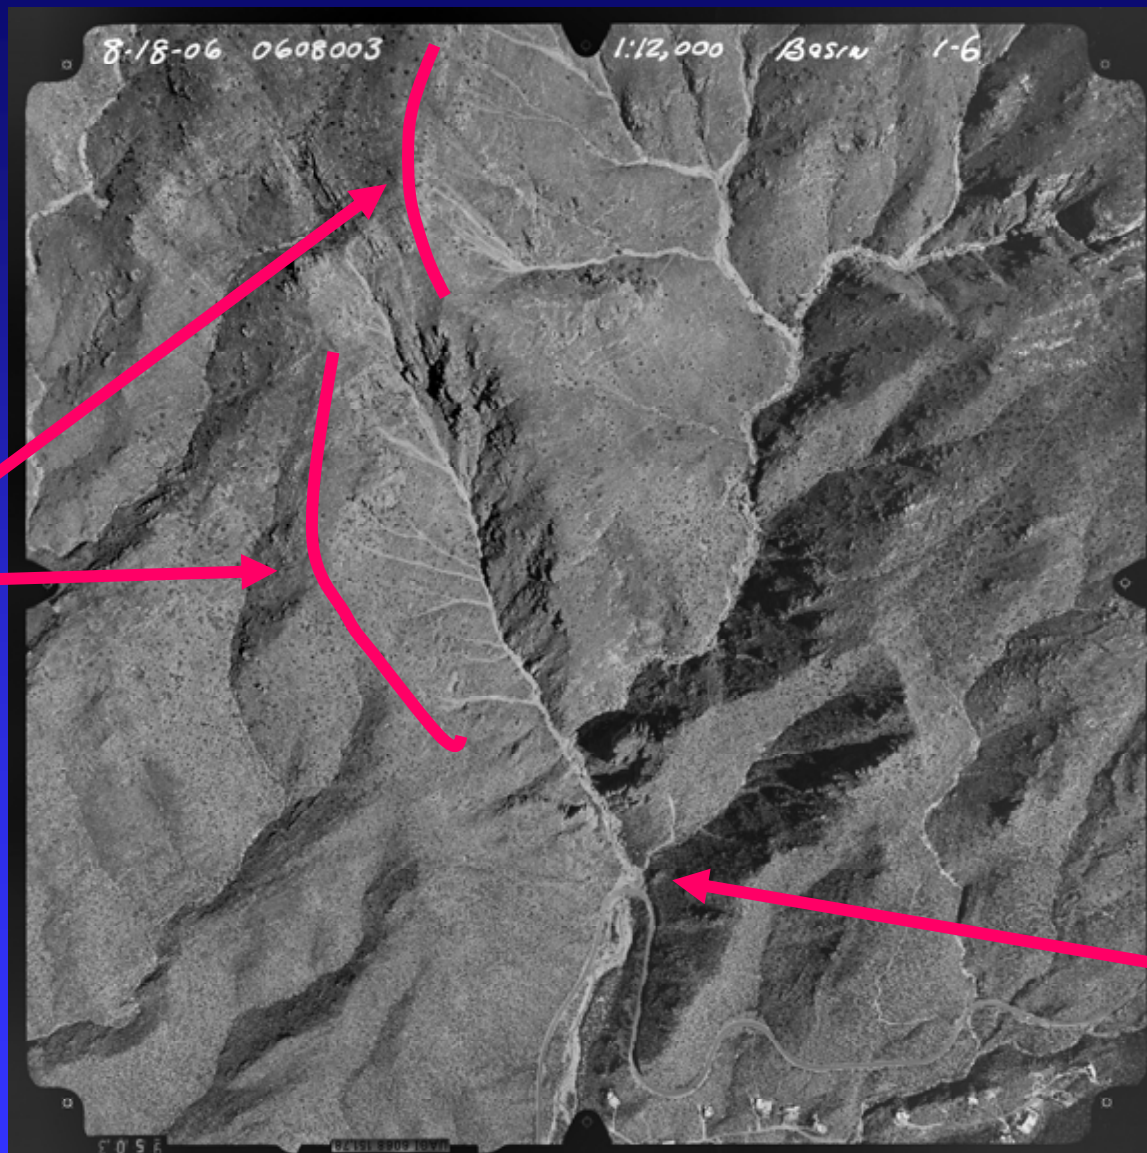
Post-storm aerial photo of Soldier Canyon

Multiple
slope
failures
on west
side of
canyon

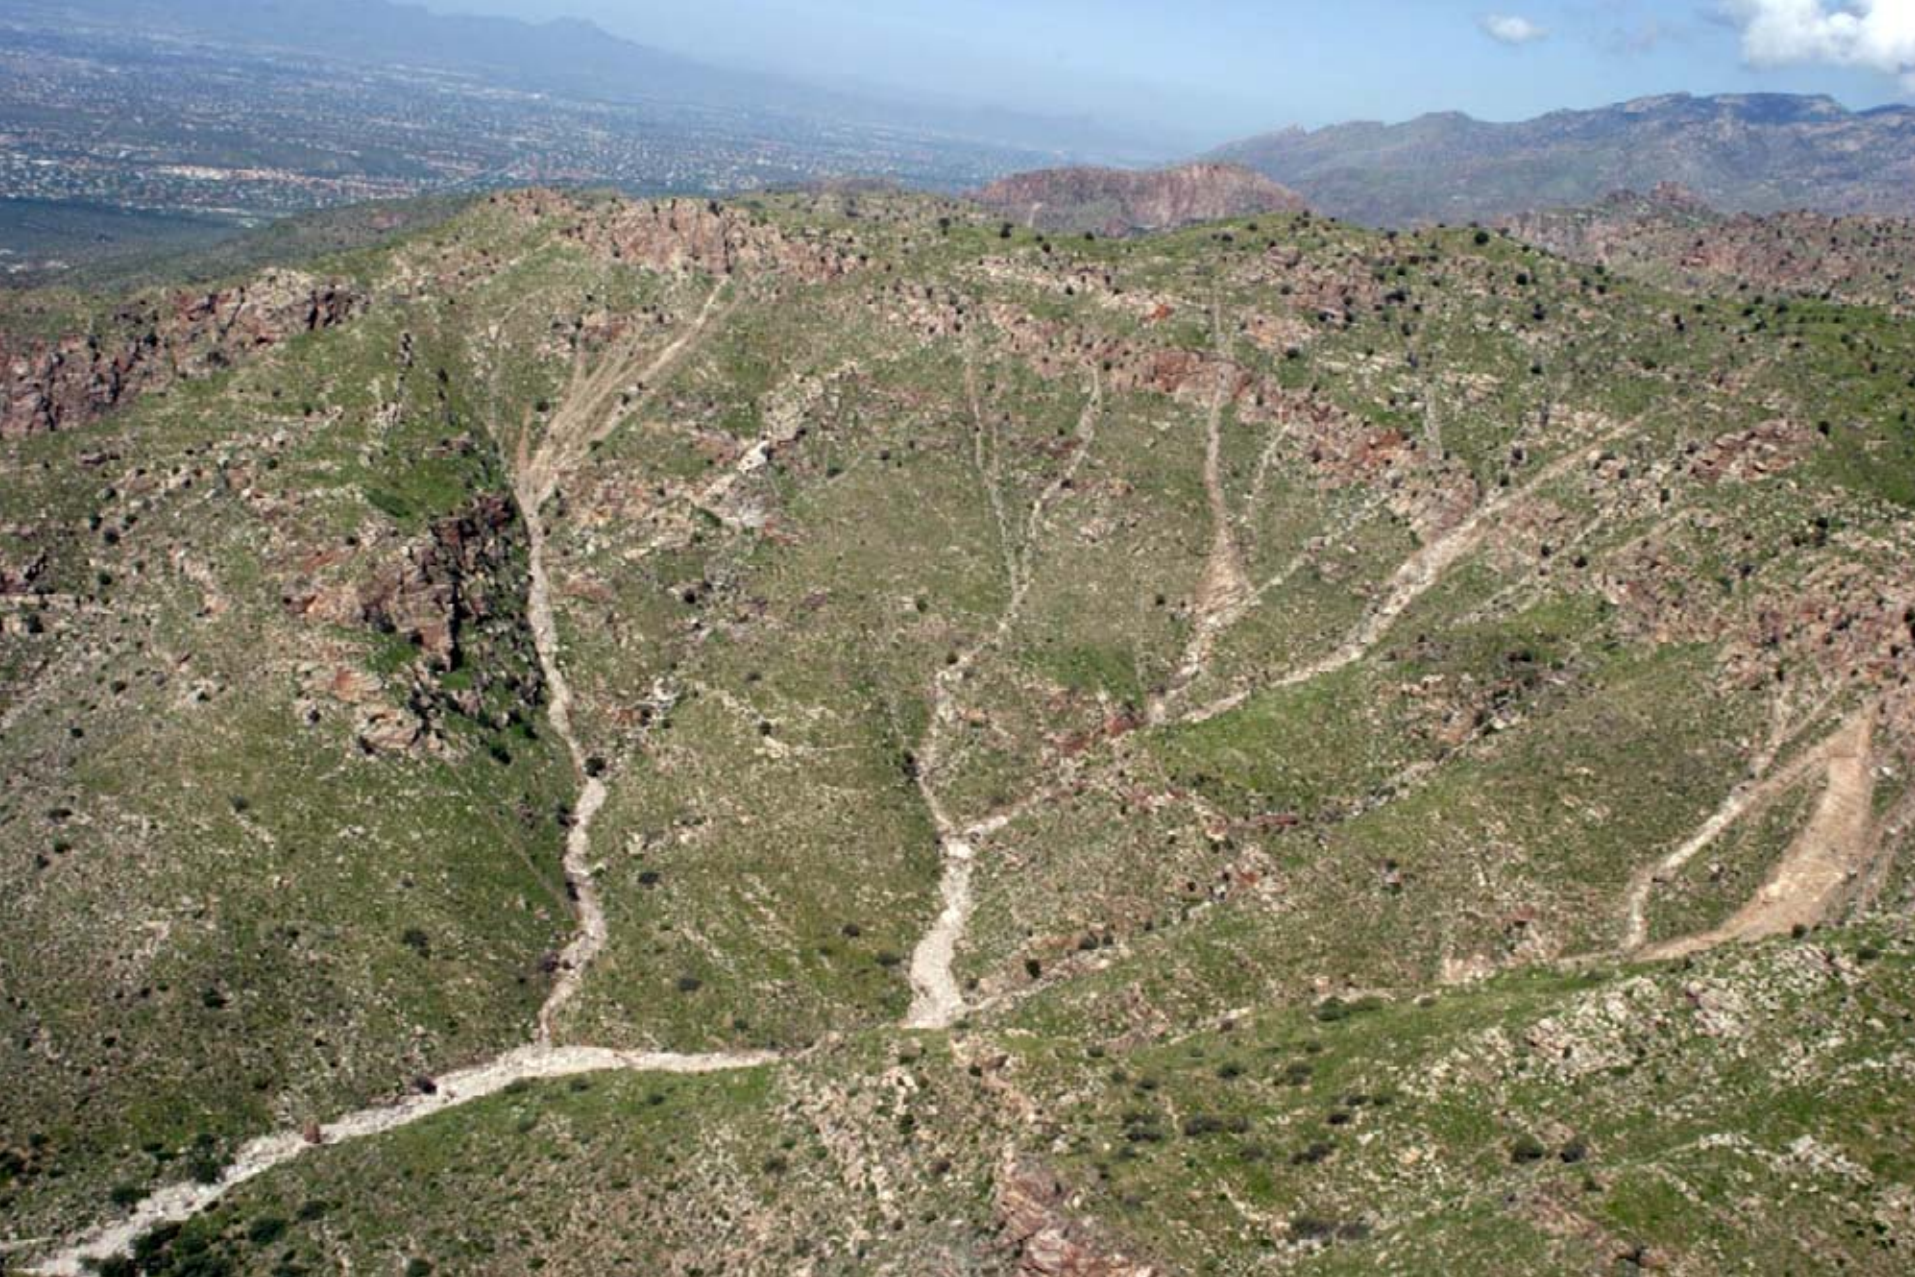
Infra-
structure
damage
at
Catalina
Highway
crossing

(Pima County Flood Control)

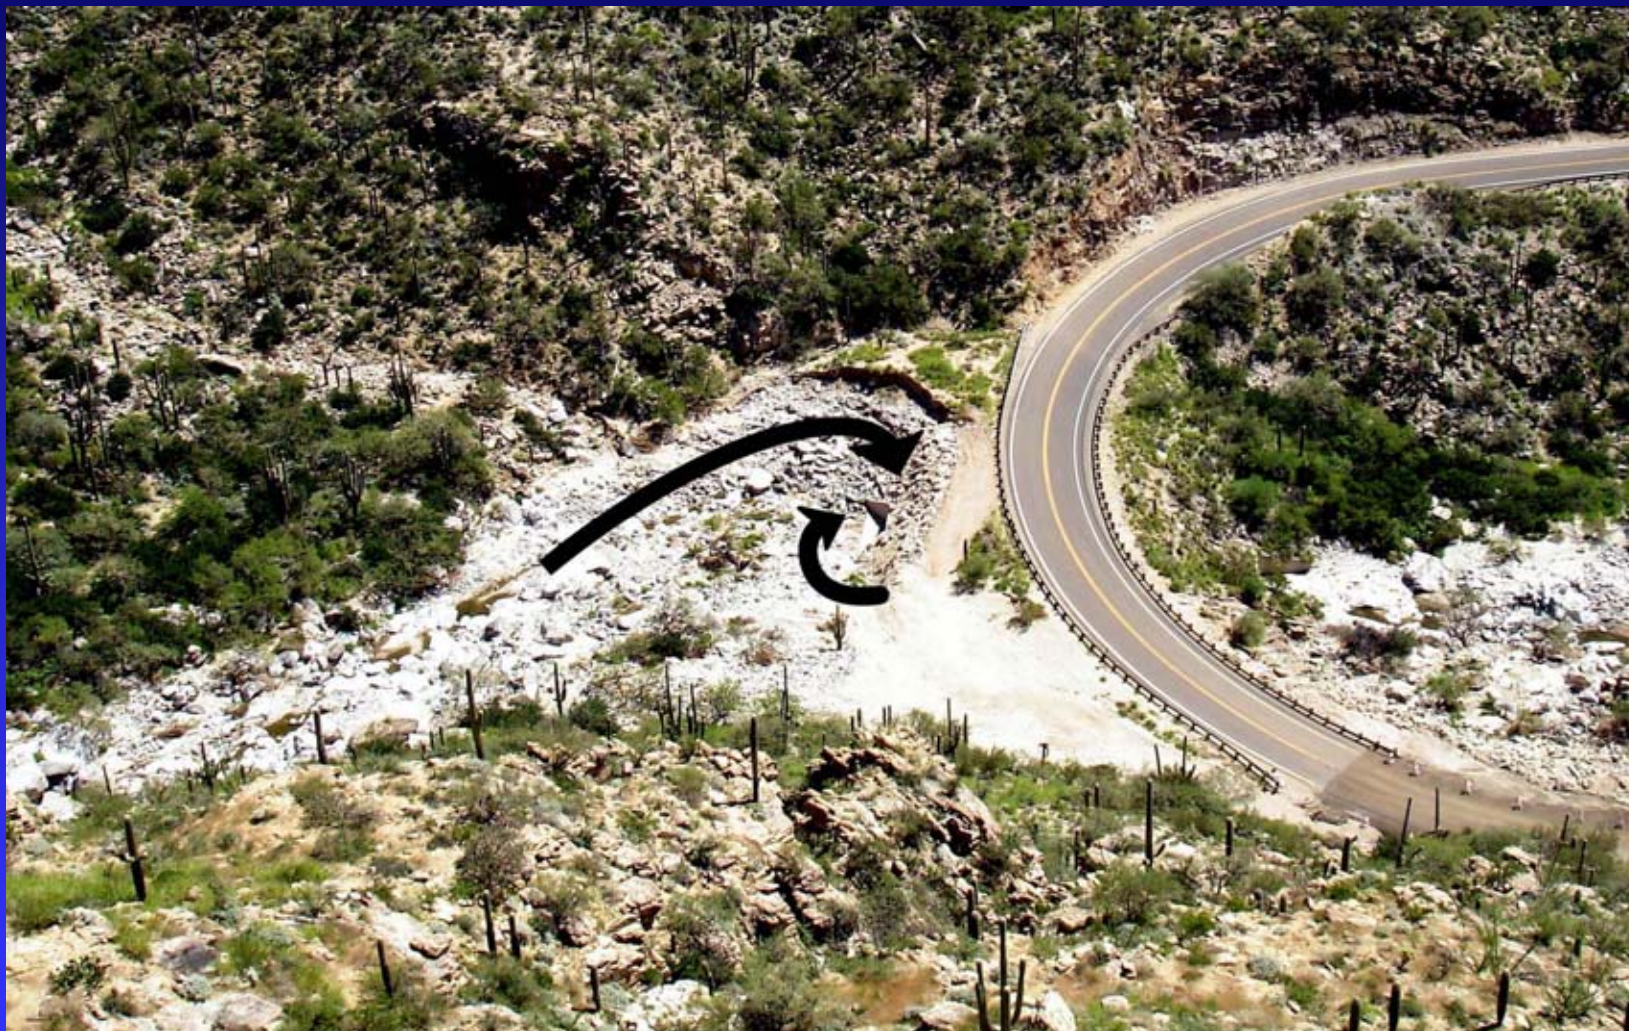
Whirlpool developed at the Catalina Highway culvert

Little deposition above culvert;
mostly erosion

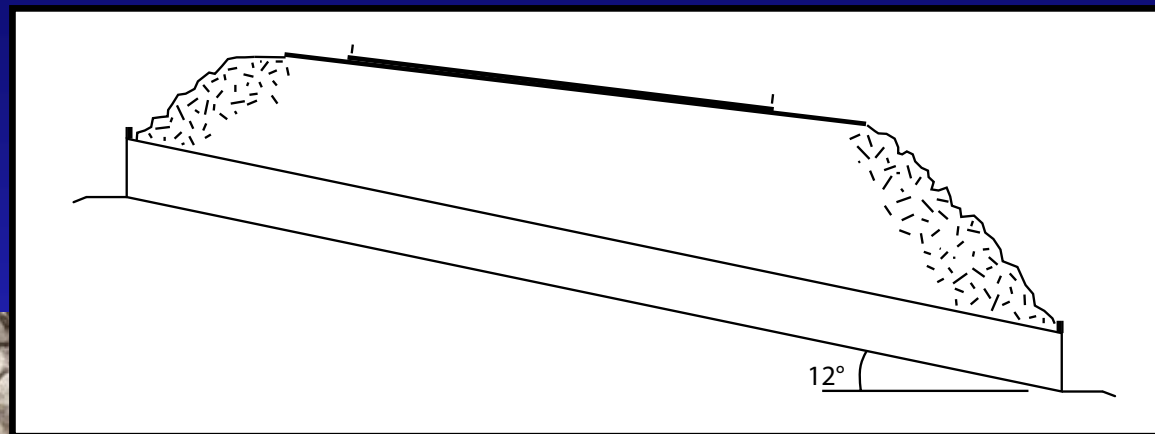
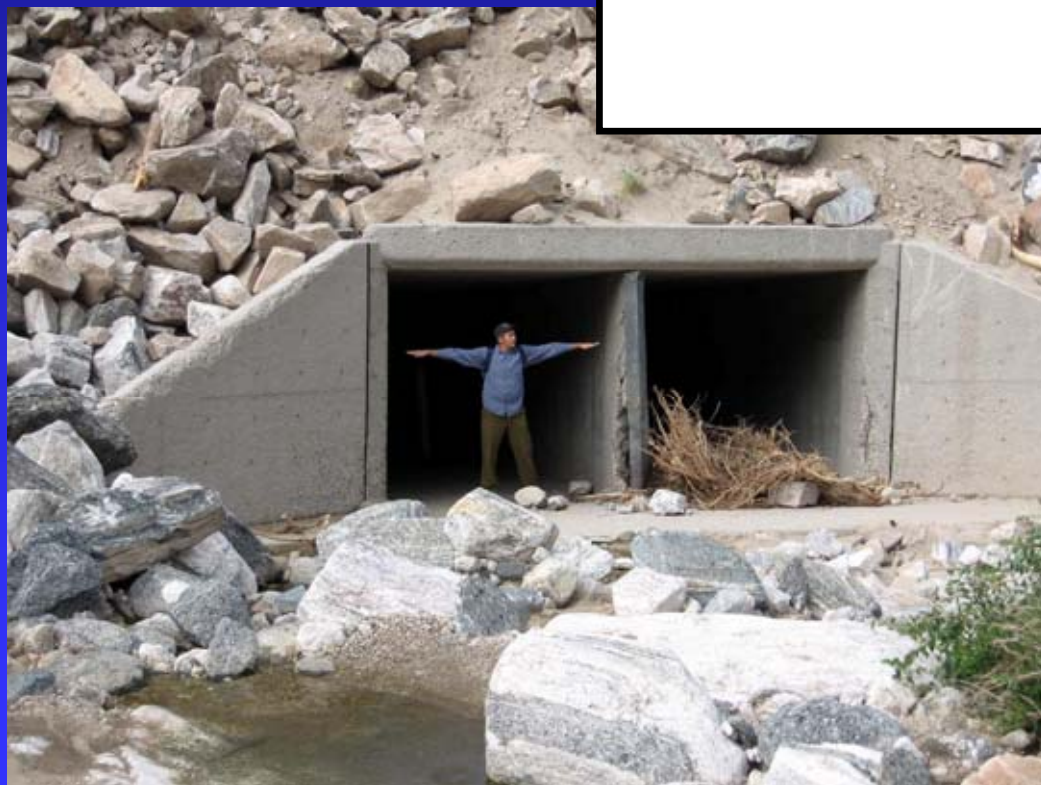
2.5 m double box culvert

Catalina Highway culvert damaged but worked beautifully

- Damage to metal plated divider
- Culvert acted as a 2.5 m sieve
- Steep slope sucked DF down

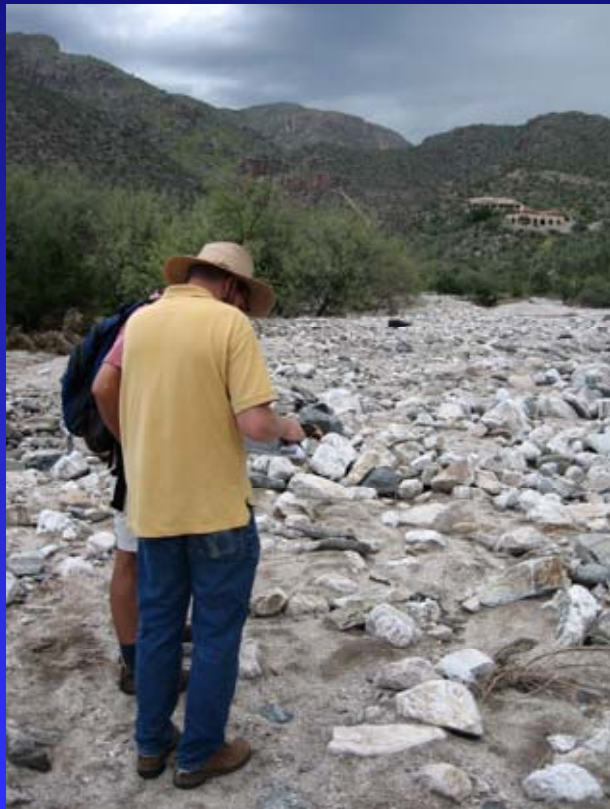
Culvert at Mt. Lemmon Short Road quickly plugged with debris-flow snout

Sands, gravels, cobbles,
boulders all in matrix

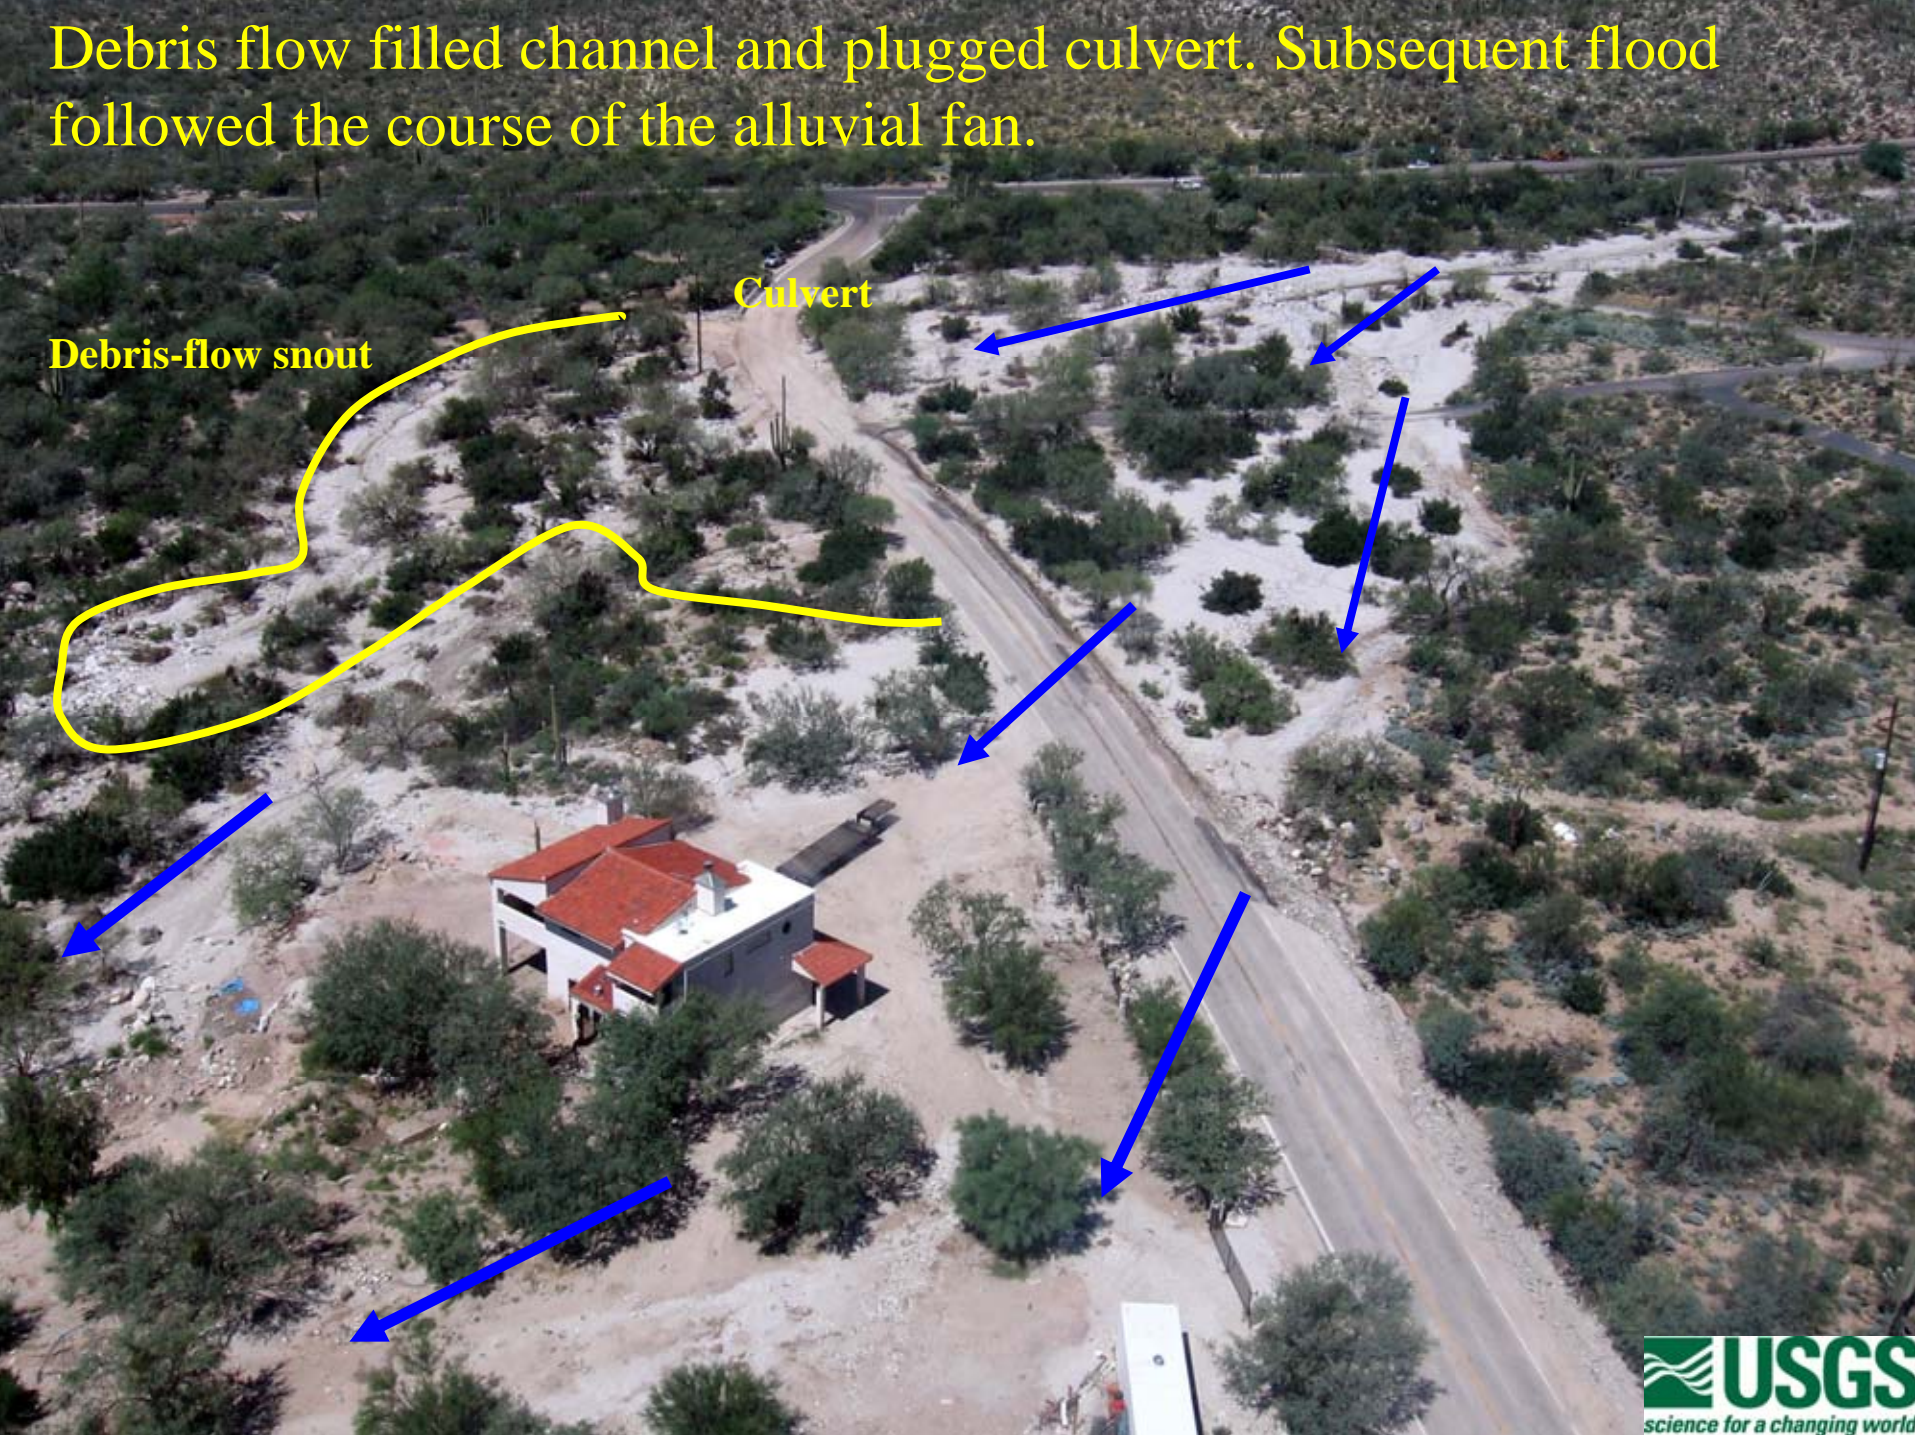
Debris-flow levee topped the guard rail

Debris flow filled channel and plugged culvert. Subsequent flood followed the course of the alluvial fan.

Debris-flow snout

Culvert

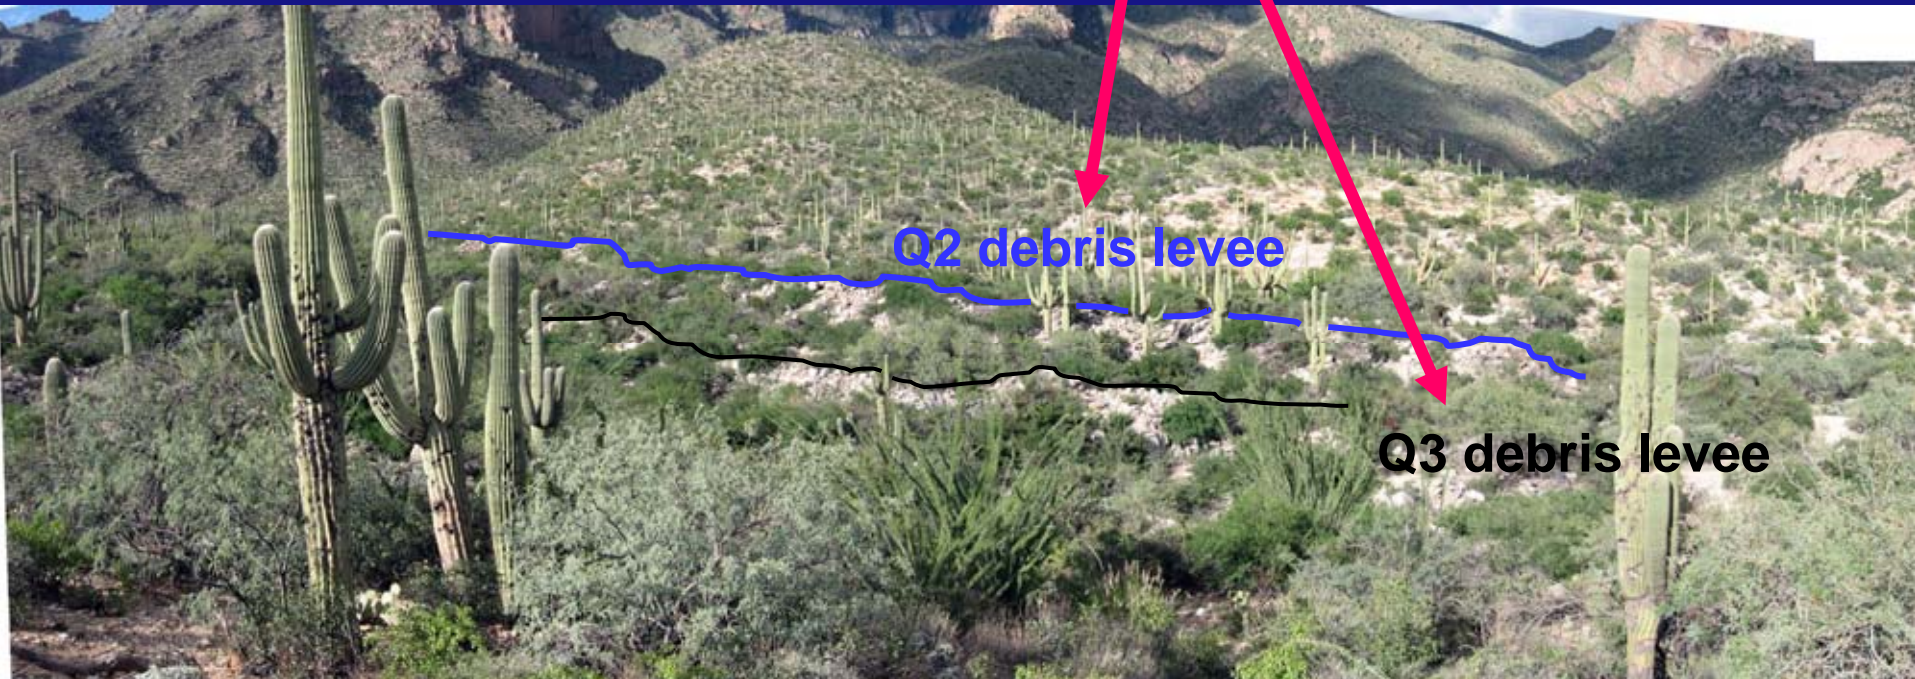
Paleo debris-flow levees near Finger Rock trail...

How old?
